I am writing to request technical review, in accordance with 24 CFR 902.68, regarding inspection report number 581624, filed on October 5, 2016 and released on October 13, 2016, for Lansdowne Park, AMP 201. The inspection report included a deduction of 7.50 points for Site/Grounds erosion/rutting areas (NLT) and a 2.94 point deduction for Site, overgrown vegetation. Total points deducted 10.44. We believe this is a material error which, if corrected, will result in a significant improvement in the property's overall score. Supporting documentation is enclosed for your review.

Office of Public Housing Real Estate Assessment Center Request for Technical Review (TR) or Database Adjustment (DBA) of a Physical Inspection Score

Inspection Number	<u>581624</u>	Project ID Number	<u>VA011000201</u>
Inspection Date	<u>10/05/2016</u>	Address of Property	<u>2624 SALEM TURNPIKE NW</u>
Project/Property Name	<u>Lansdowne Park</u>	City, State, Zip	<u>ROANOKE VA 24017</u>
Date of Request	<u>10/13/2016</u>	Contact Name	<u>David Bustamantye</u>
TR or DBA?	<u>TR</u>

TECHNICAL REVIEW REQUEST -INSPECTION
NUMBER 581624 – LANSDOWNE PARK

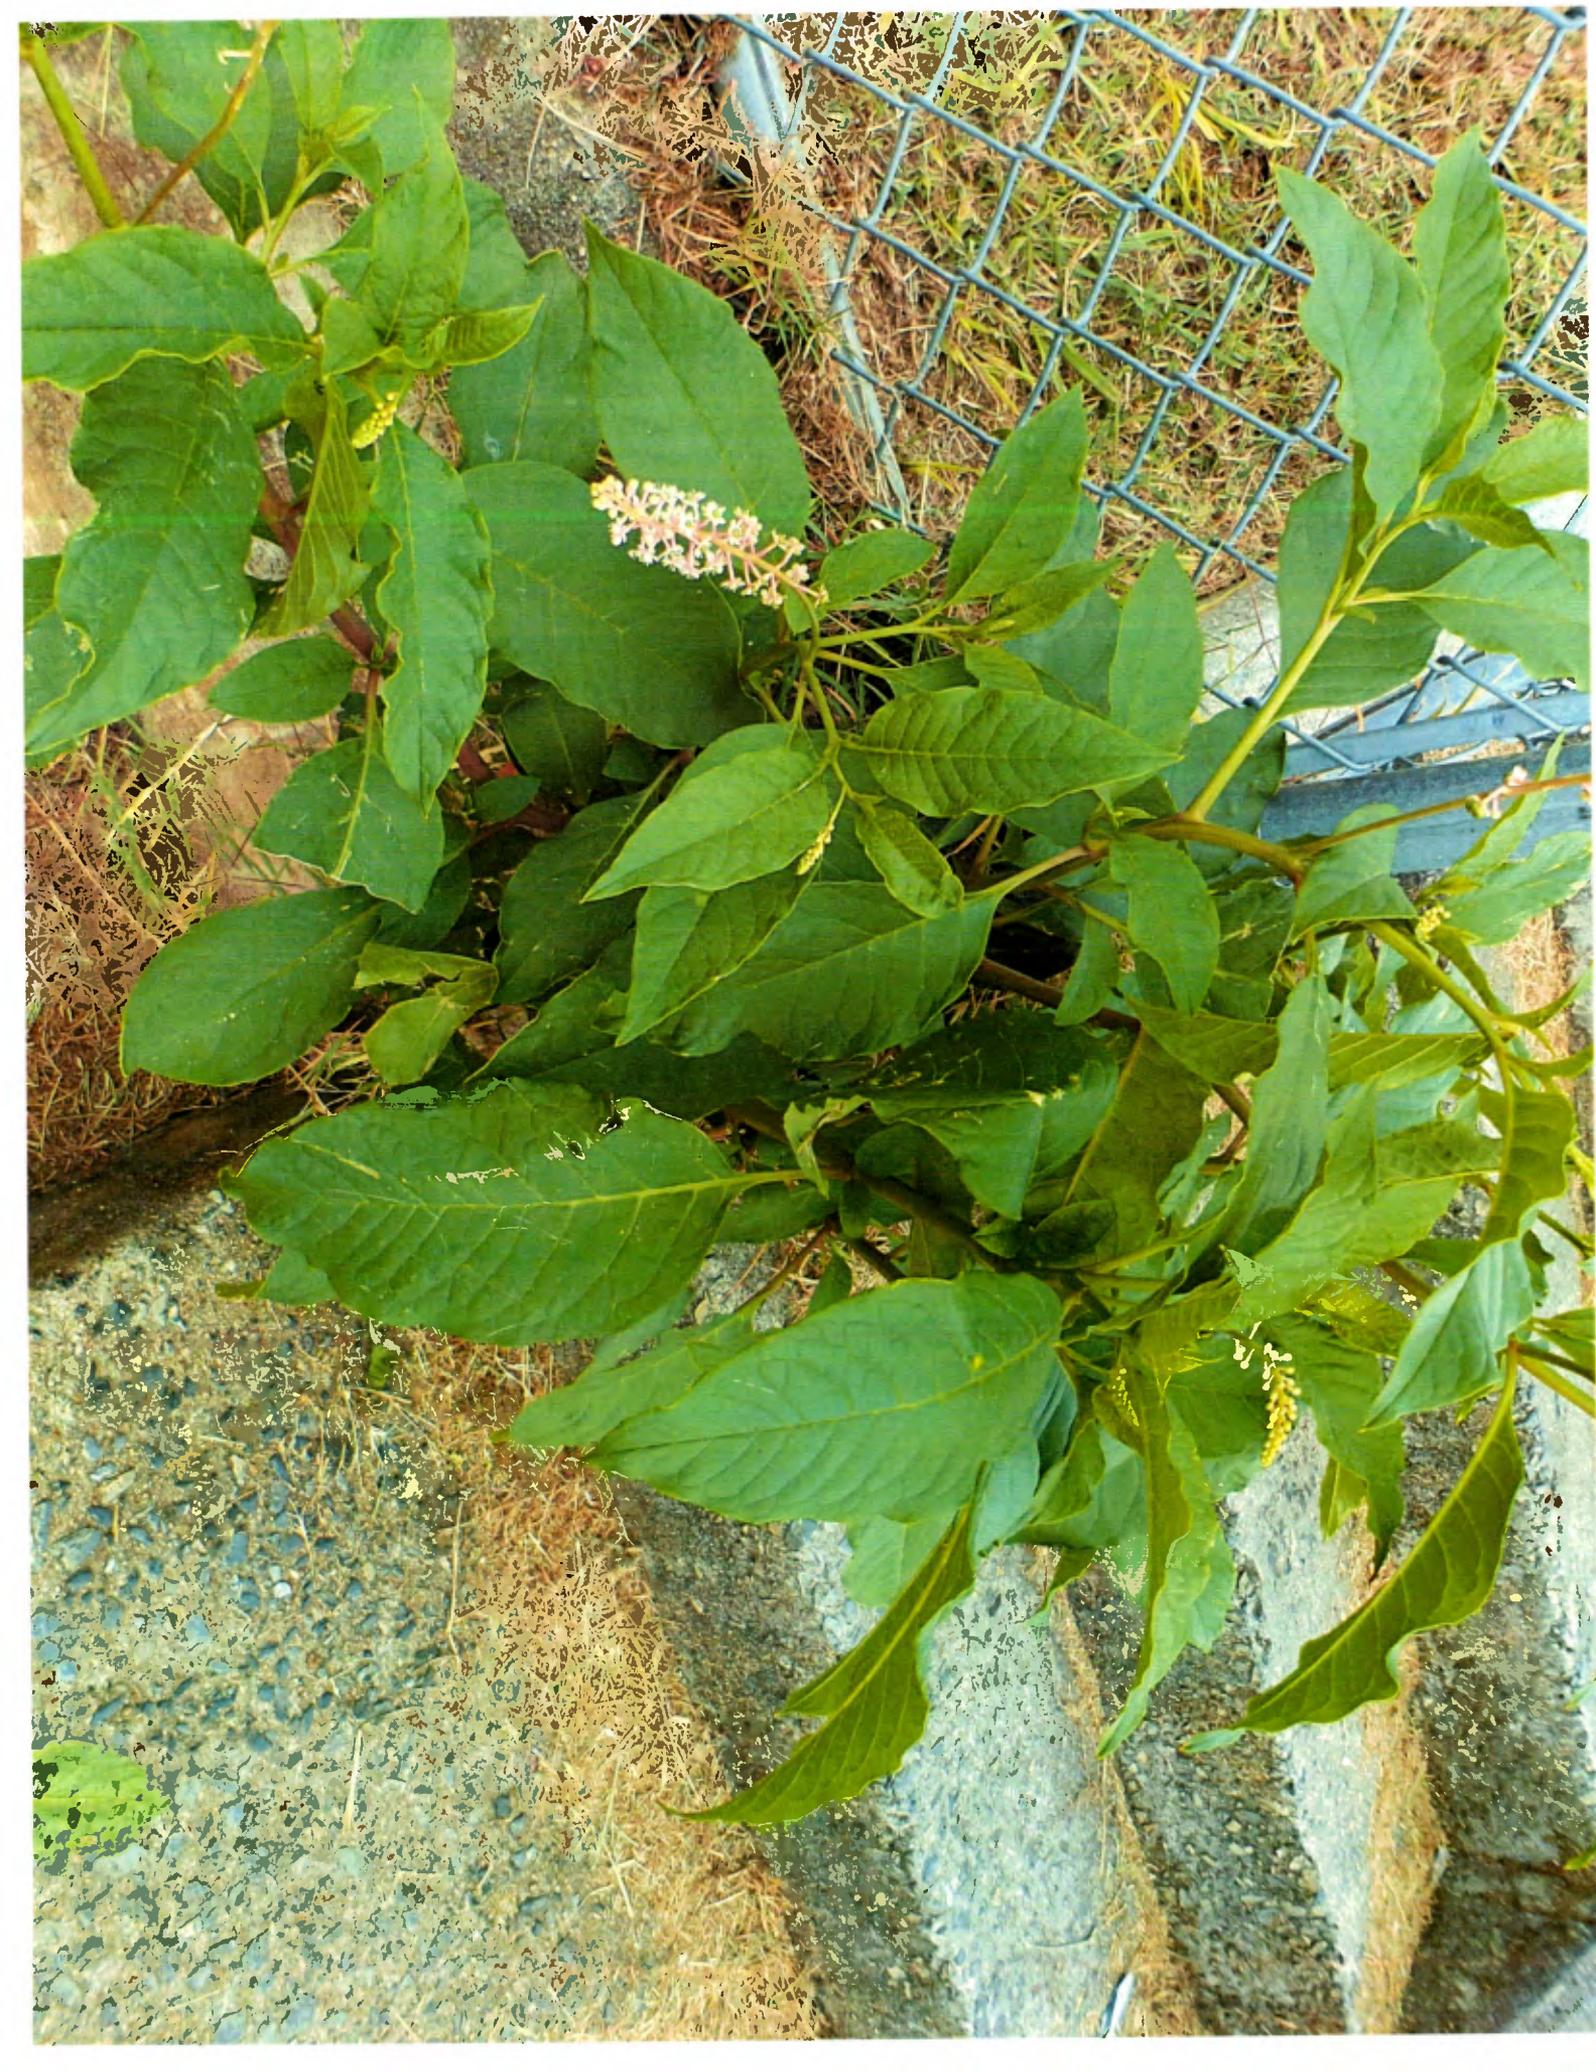
SUPPORTING DOCUMENTS

Site - OVERGROWN/PENETRATING VEGETATION (GROUNDS) L2, 2.94 POINT DEDUCTION.

Per the UPCS GUIDANCE & PROTOCOL CLARIFICATIONS bulletin issued by REAC on 5/13/2016 the picture described as overgrown vegetation does not meet the threshold for for citing this as a deficiency. As a matter of fact is it defined as what should not be considered overgrown vegetation by REAC Inspectors. RRHA requests that the 2.94 points be reinstated and that we receive a rescore.

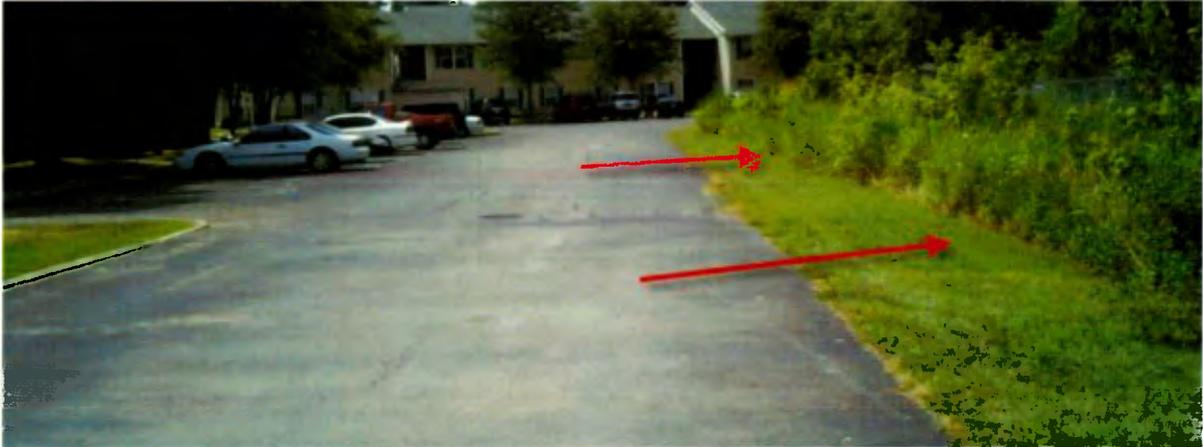
- Are weeds and grass overgrown in an area of the property that is not in use a defect or not? (e.g. see photo below - a strip of land between the driveway and property fence) No defect

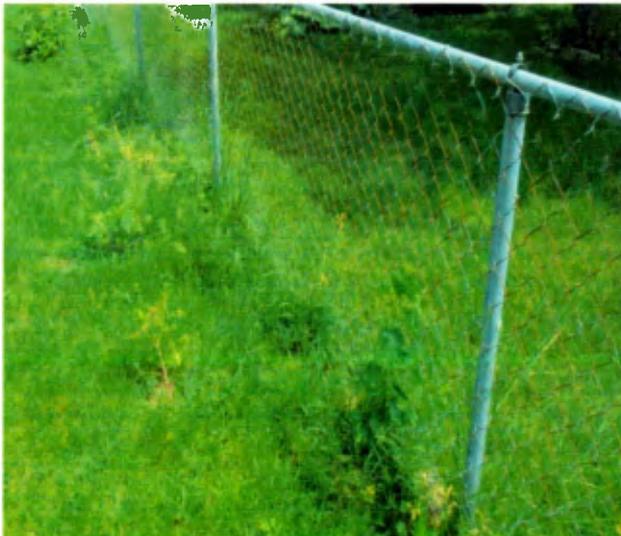
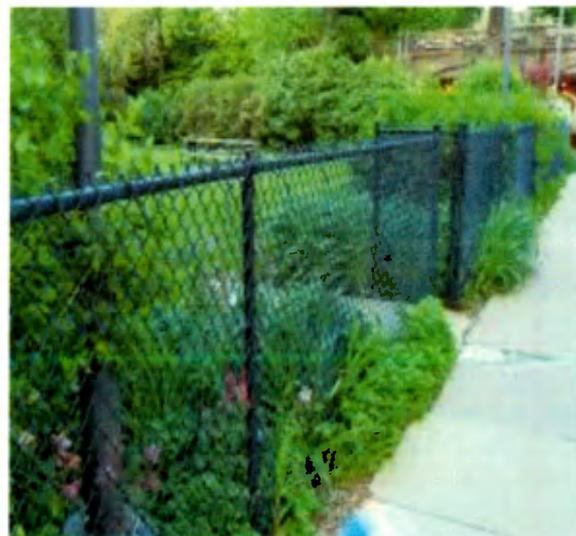
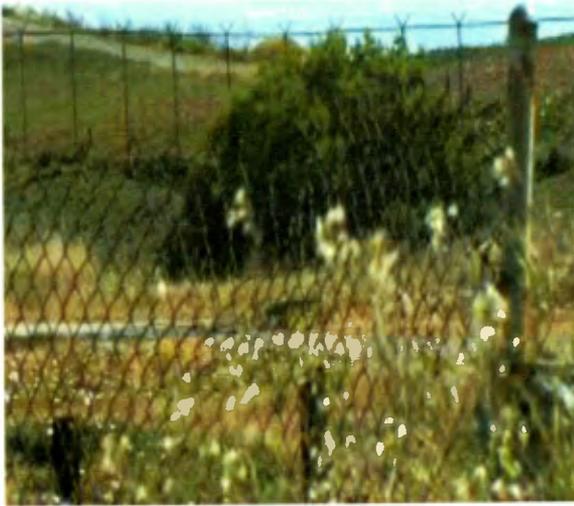
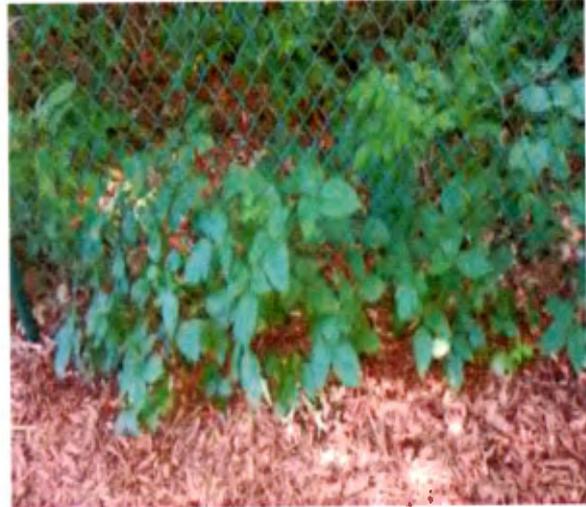
Four examples of vegetation contacting a fence that is acceptable – No defect

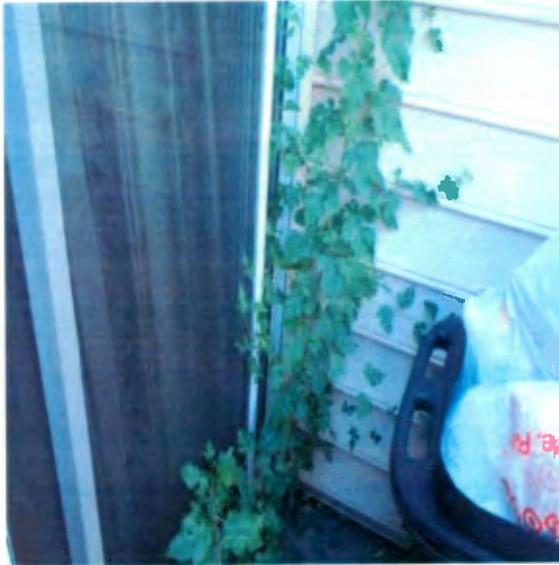
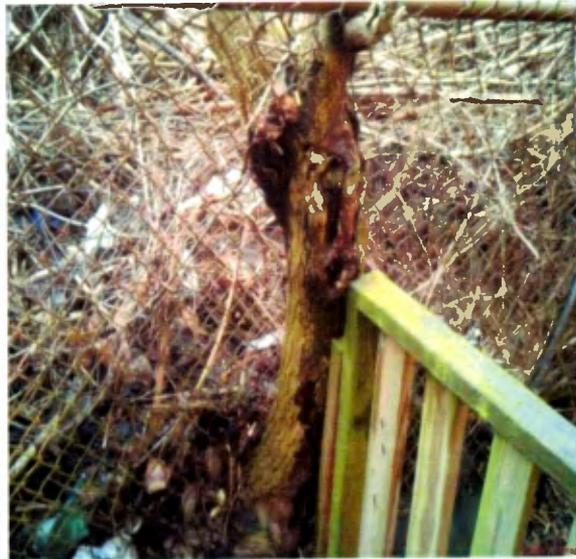
Four examples below of vegetation contacting a fence or building that is **NOT** acceptable and is a defect.

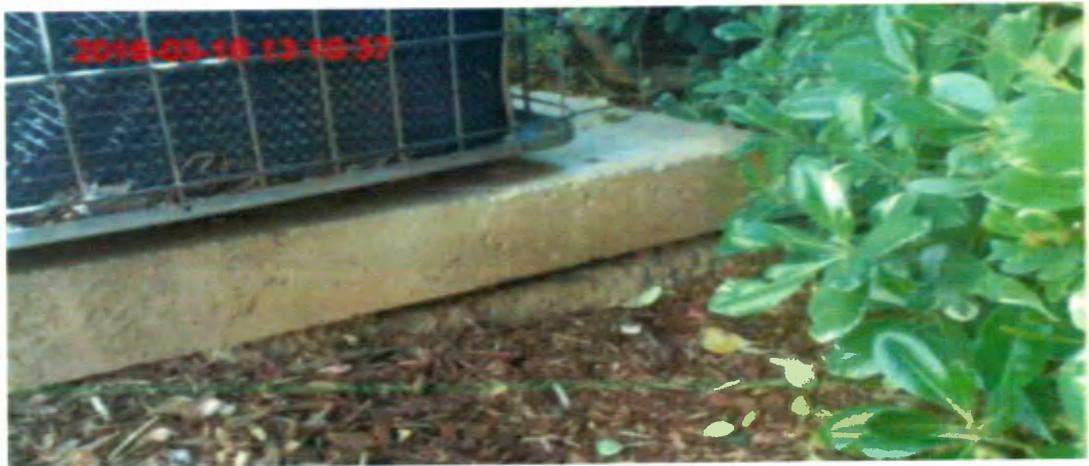
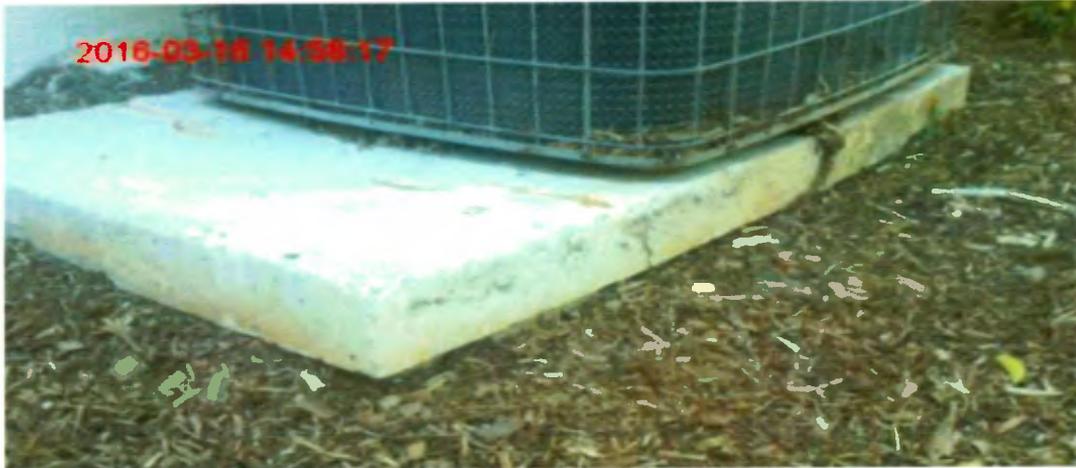
- Here are two actual examples of what inspectors are recording as erosion. Neither of these meets our definition of erosion and should not have been recorded.

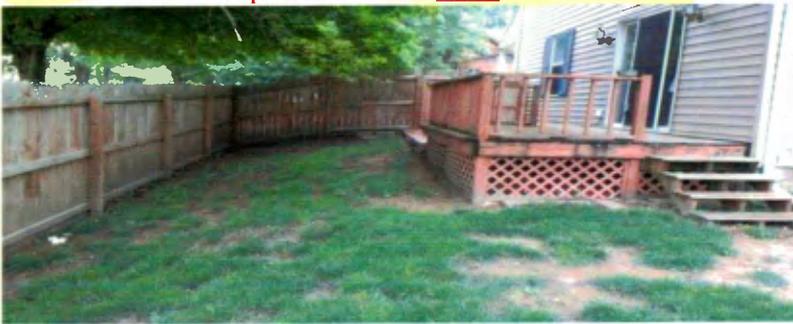
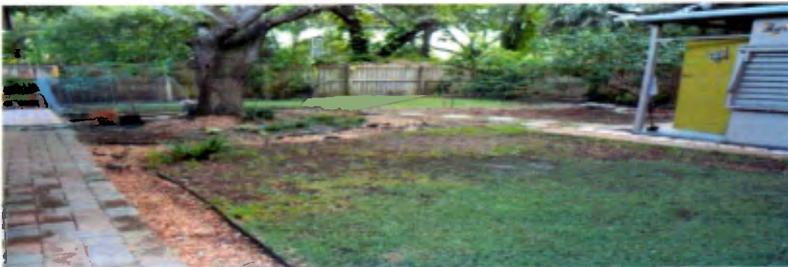
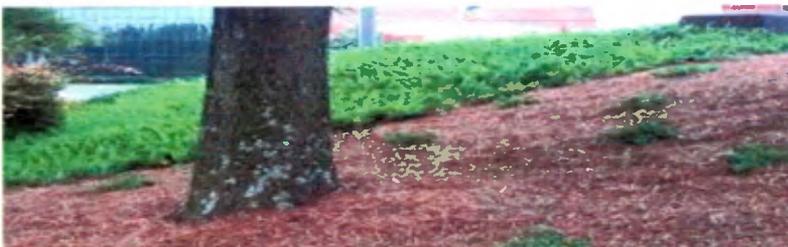
Often inspectors record a defect for erosion because the area under a tree or path that residence use does not have grass growing on it. This is not correct. Erosion shall be evaluated only if there is evidence of displaced soil.

Here are three examples of what is NOT erosion:
