DATABASE ADJUSTMENT REQUEST INSPECTION NUMBER 581634 — JAMESTOWN
PLACE

1627-1635 QUEEN ANN DR SITE ERROSION

7.50 POINT DEDUCTION

Inspection Summary Report (POA) for Inspection #581634

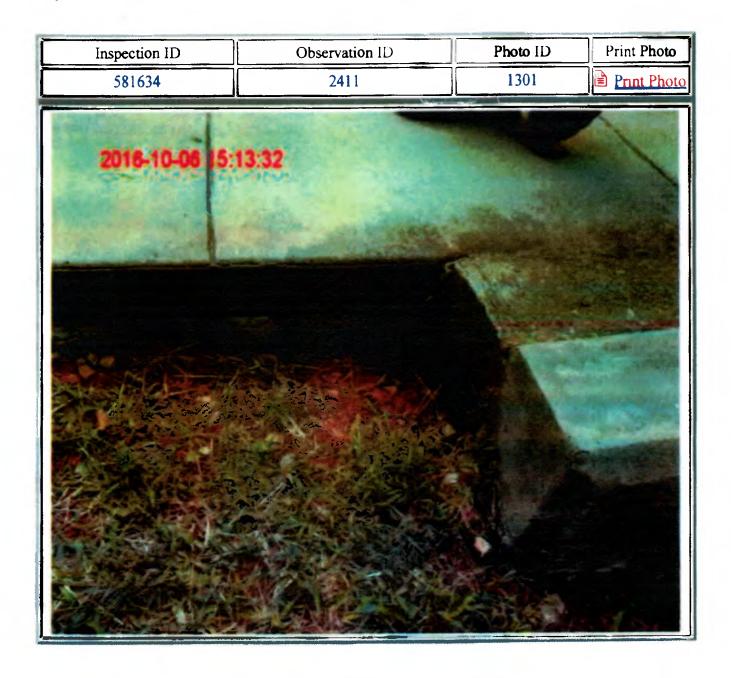
At your request, I did a site visit to 1627 Queen Anne Drive noted in inspection #581634. The area, as seen in the photograph dated October 10, 2016, is adjacent to the sidewalk and at the end of a small retaining wall.

In my professional opinion as a licensed civil engineer, the low elevation of the soil in relation to the sidewalk is not the result of erosion, but is the result of a failure to fully backfill against the sidewalk when it was constructed and with the passing of time the settlement of the soil that was disturbed when the sidewalk was installed. There are no conditions present that will result in damage to surrounding structures or systems.

Clearly, the pictures you forwarded are not pictures of active erosion, and no land disturbance of more than 2,000 SF exists, even if all the occurances are added together. These appear to be landscape and regular maintenance issues, and should, in our eyes, never been classified as erosion violations.
