CITY OF  
ROANOKE    
REDEVELOPMENT  
AND HOUSING  
AUTHORITY

I am writing to request technical review, in accordance with 24 CFR 902.68, regarding inspection report number 581634, filed on October 6, 2016 and released on October 12, 2016, for Jamestown Place, AMP 207. The inspection report included a deduction of 7.50 points for Site/Grounds erosion/rutting areas (NLT). We believe this is a material error which, if corrected, will result in a significant improvement in the property's overall score.

TECHNICAL REVIEW REQUEST -INSPECTION  
NUMBER 581634 – JAMESTOWN PLACE

1627-1635 QUEEN ANN DR SITE  
ERROSION

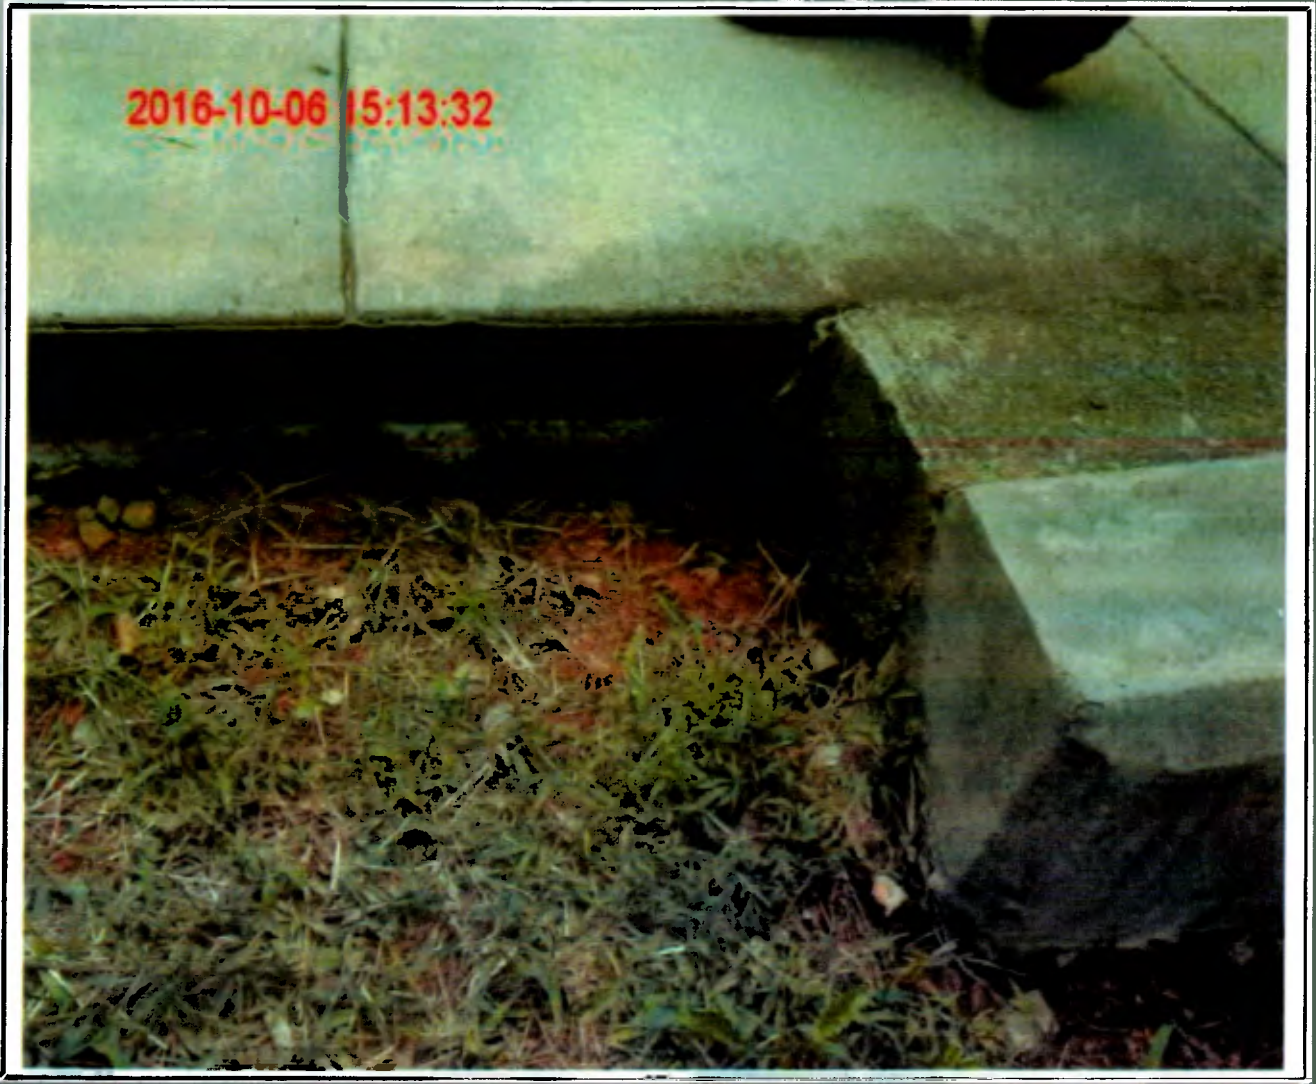
Inspection ID	Observation ID	Photo ID	Print Photo
581634	2411	1301

At your request, I did a site visit to 1627 Queen Anne Drive noted in inspection #581634. The area, as seen in the photograph dated October 10, 2016, is adjacent to the sidewalk and at the end of a small retaining wall.

In my professional opinion as a licensed civil engineer, the low elevation of the soil in relation to the sidewalk is not the result of erosion, but is the result of a failure to fully backfill against the sidewalk when it was constructed and with the passing of time the settlement of the soil that was disturbed when the sidewalk was installed. There are no conditions present that will result in damage to surrounding structures or systems.

Grounds	1627-1635 QUEEN ANN DR SE	Site - Erosion/Rutting Areas (Grounds) (NLT) - L3	- Erosion/rutting - Severe runoff has displaced soil causing current or potential damage to surrounding structures or systems
---------	---------------------------	---	--
