CITY OF
ROANOKE  
REDEVELOPMENT
AND HOUSING
AUTHORITY

Office of Public Housing Real Estate Assessment Center Request for Technical Review (TR) or Database Adjustment (DBA) of a Physical Inspection Score

Inspection Number	581634	Project ID Number	VA011000207
Inspection Date	10/07/2016	Address of Property	1533 PIKE LANE SE
Project/Property Name	JAMESTOWN PLACE	City, State, Zip	ROANOKE VA 24014
Date of Request	10/12/2016	Contact Name	David Bustamantye
TR or DBA?	TR

TECHNICAL REVIEW REQUEST -INSPECTION
NUMBER 581634 – JAMESTOWN PLACE

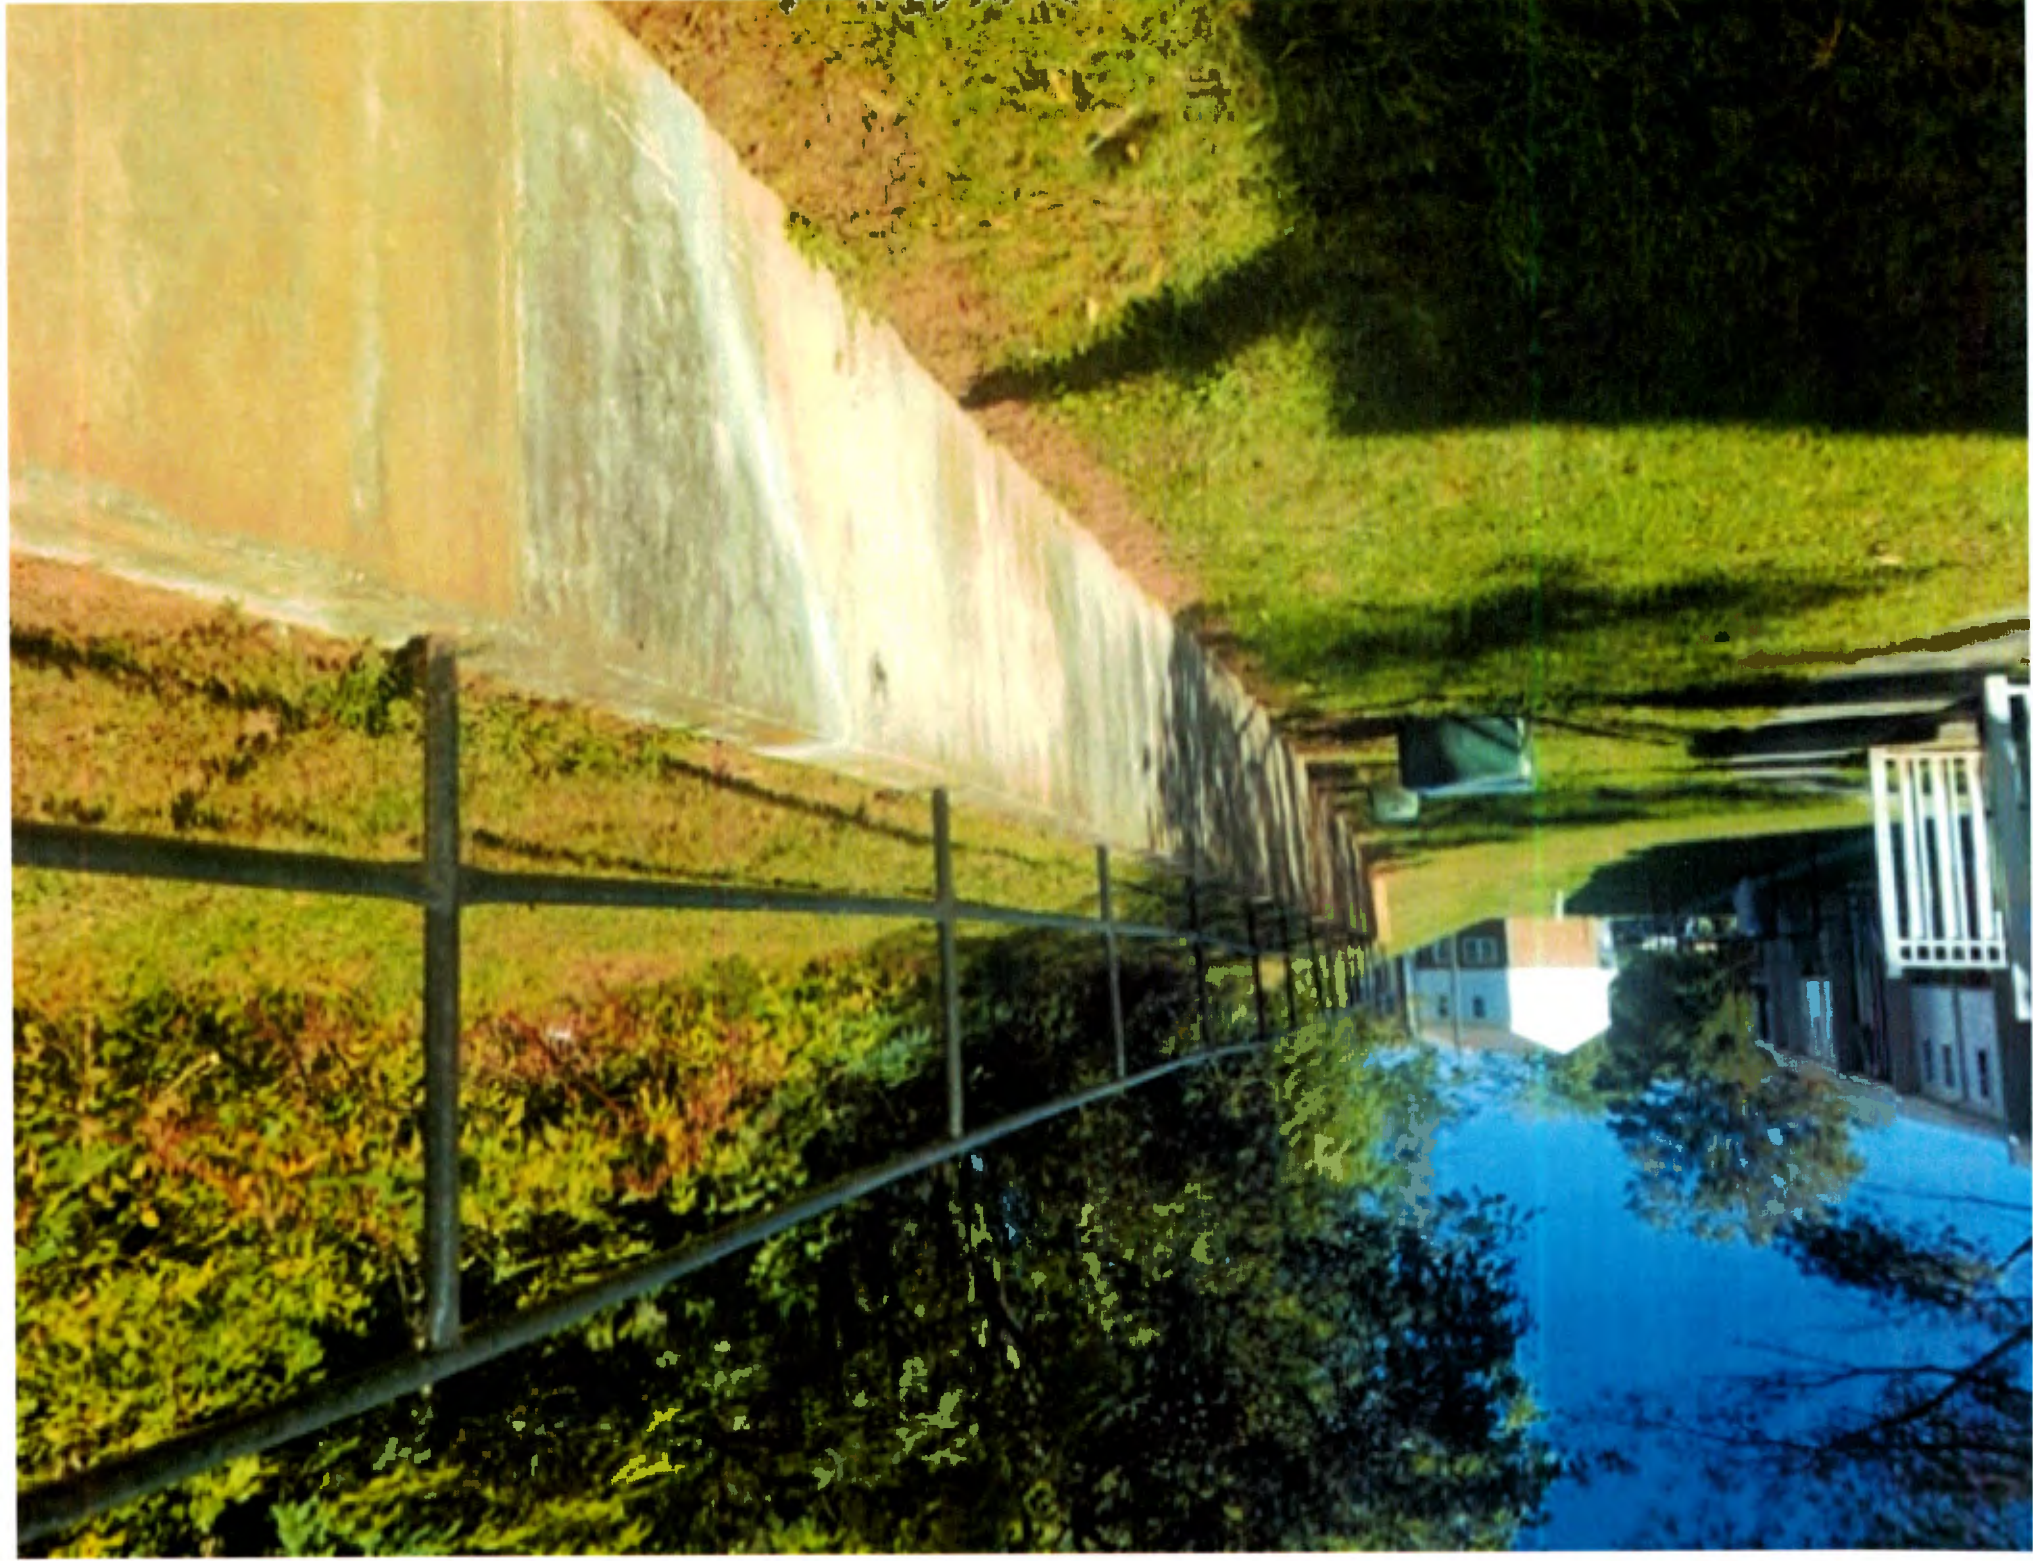
2144-2162 KING CHARLES AVE
SITE/RETAINING WALLS
DAMAGED/FALLING OR LEANING

Retaining Walls Site - Damaged/Falling/Leaning (Retaining Walls) Level 1, 1.63 POINT DEDUCTION

Retaining wall had minor hairline cracks which had been repaired, other than that, the wall is solid and no signs of falling.

RRHA has provided a letter from a contractor indicating that the wall in question does not present as damaged, falling or leaning. RRHA requests that the 1.63 point deduction be added to our final score and that a rescore be conducted.

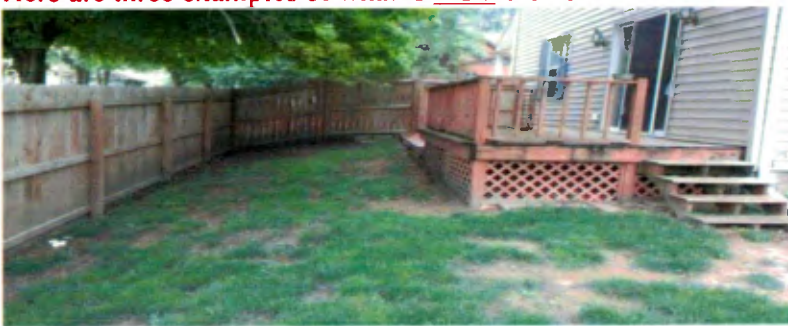
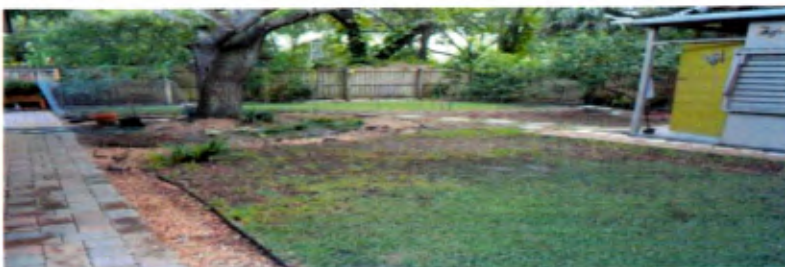
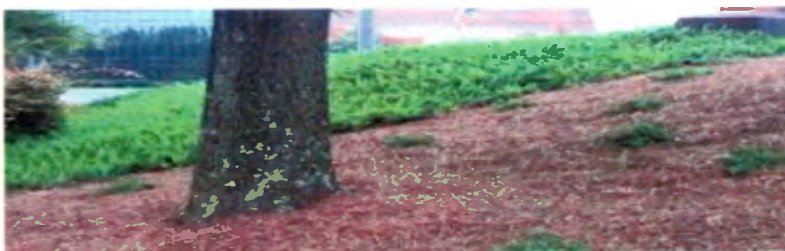
Often inspectors record a defect for erosion because the area under a tree or path that residence use does not have grass growing on it. This is not correct. Erosion shall be evaluated only if there is evidence of displaced soil.

Here are three examples of what is NOT erosion:

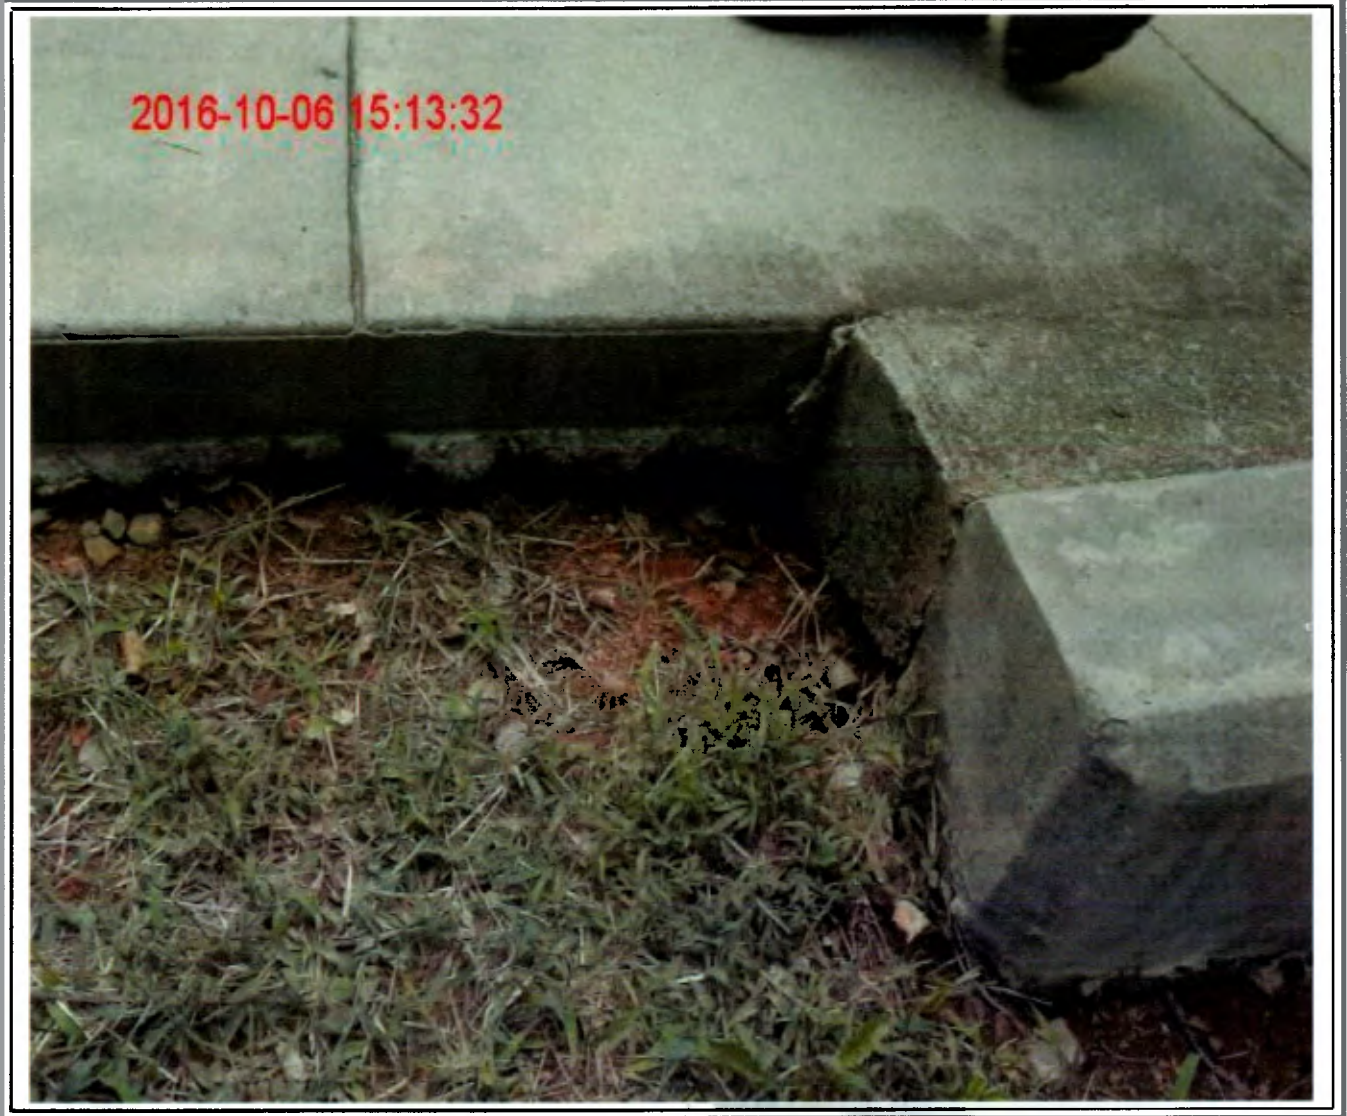
Inspection ID	Observation ID	Photo ID	Print Photo
581634	2411	1301

Site - Erosion/Rutting Areas (Grounds) (NLT), Level 3, 7.50 point deduction.

Per the inspectors photo and comparing it to UPCS GUIDANCE & PROTOCOL CLARIFICATIONS bulletin issued by REAC on 5/13/2016 this picture does not meet the threshold for erosion. As a matter of fact is it defined as what should not be considered erosion by REAC Inspectors. RRHA requests that the 7.50 points be reinstated and that we receive a rescore.
