TECHNICAL REVIEW REQUEST
INSPECTION NUMBER 618261
LINCOLN TERRACE, AMP 202

HS – TRIPPING (HAZARDS)
5.91 POINT DEDUCTION

Office of Public Housing Real Estate Assessment Center Request for Technical Review (TR) or Database Adjustment (DBA) of a Physical Inspection Score

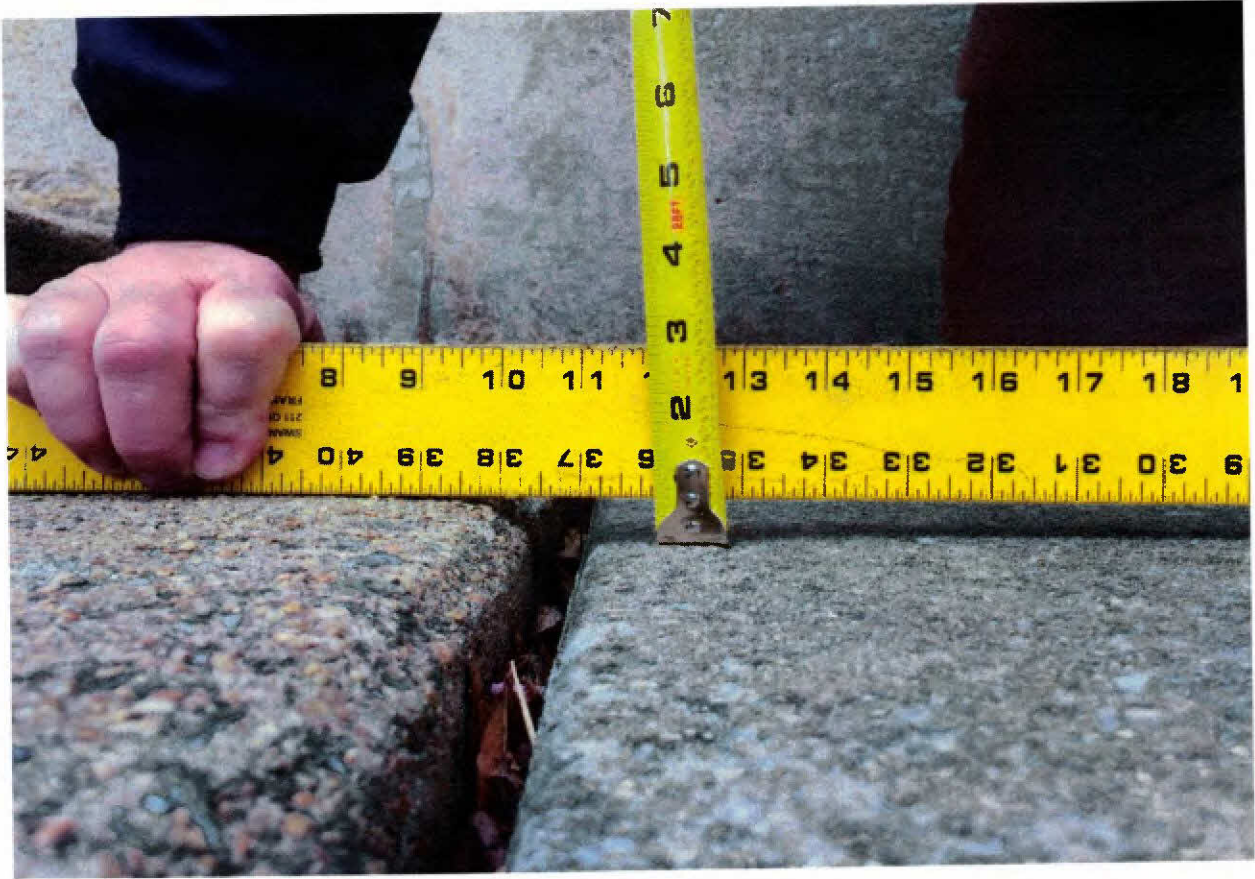
At your request, I did a site inspection of the sidewalk at the Villages at Lincoln for tripping hazard.

A straight edge was used to determine the vertical difference between the surface elevations of the two adjacent sections of concrete being investigated. The difference in elevation was determined to be approximately 9/16 of an inch (see attached photograph). Since the difference between the surface elevations of the two sections of sidewalk is less than 3/4 of an inch, no tripping hazard is present.
