DATABASE ADJUSTMENT REQUEST  
INSPECTION NUMBER 618225  
LANSDOWNE PARK, AMP 201

HS – TRIPPING (HAZARDS)  
5.79 POINT DEDUCTION

**REQUEST FOR  
DATABASE  
ADJUSTMENT**

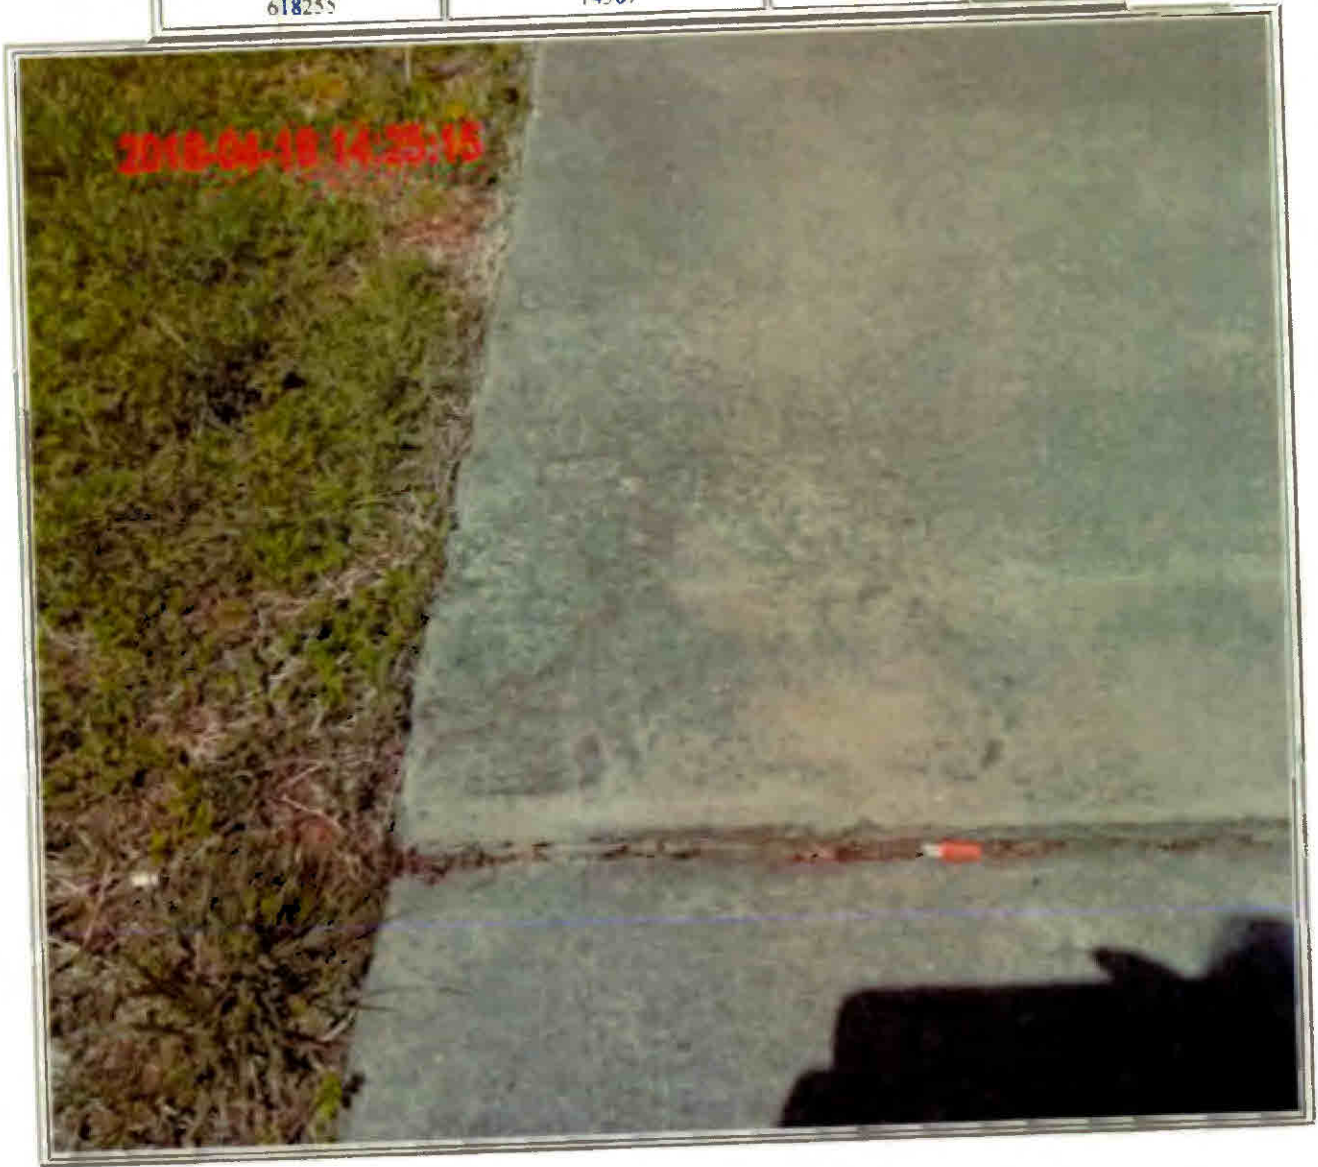
2436 Delta

Inspector cited a HS - Tripping (Hazards) in the walkway into a unit. This citation resulted in a 5.79 point deduction of RRHA overall score.

The site manager and maintenance employee accompanying the inspector attempted to illustrate that the deficiency cited was in modernization and attempted to provide the inspector with the Purchase Order listing this specific address as one of many that the contractor had been retained to complete work. The inspector indicated that we would have to appeal the citation. RRHA has included a Purchase Order and the contractor's scope of work both dated prior to the REAC inspection. RRHA requests that the 5.79 points that were deducted from our final score be reinstated and a rescore be completed.
