Office of Public Housing Real Estate Assessment Center Request for Technical Review (TR) or Database Adjustment (DBA) of a Physical Inspection Score

Inspection Number	581650	Project ID Number	VA011000210
Inspection Date	9/15/2016	Address of Property	2034 Indian Village Lane SE
Project/Property Name	Indian Village	City, State, Zip	Roanoke, VA, 24013
Date of Request	9/20/2016	Contact Name	David Bustamante
TR or DBA?	TR

CITY OF ROANOKE REDEVELOPMENT AND HOUSING AUTHORITY

TECHNICAL REVIEW REQUEST -INSPECTION NUMBER 581650 – INDIAN VILLAGE

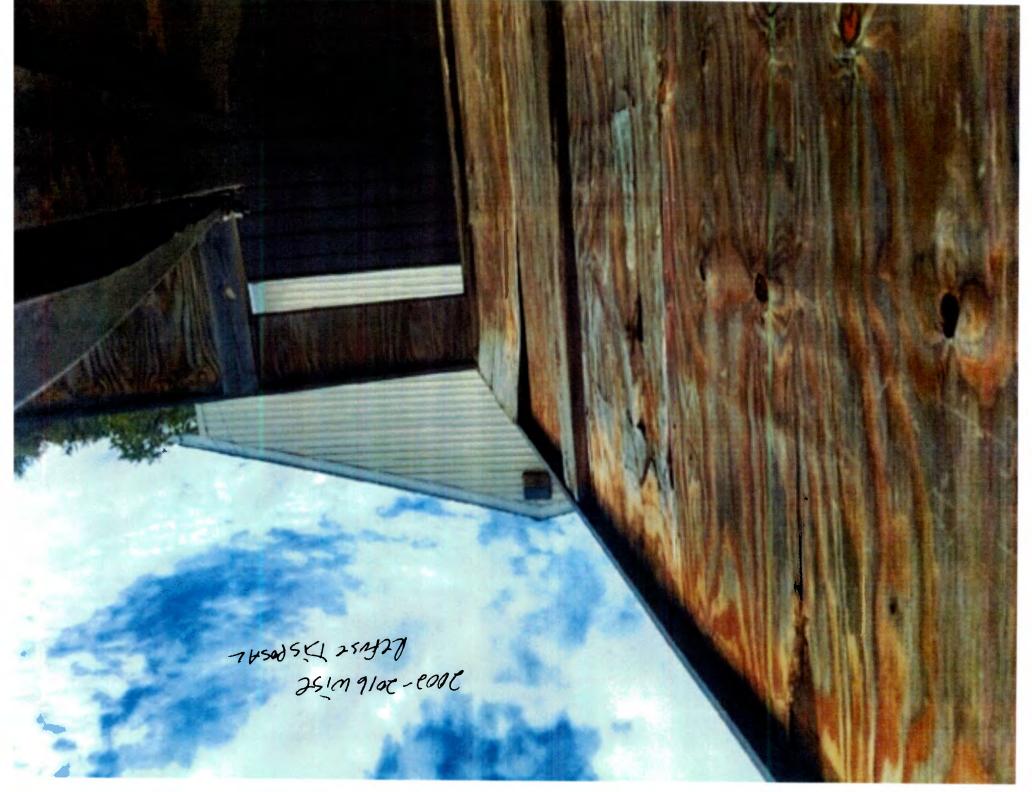
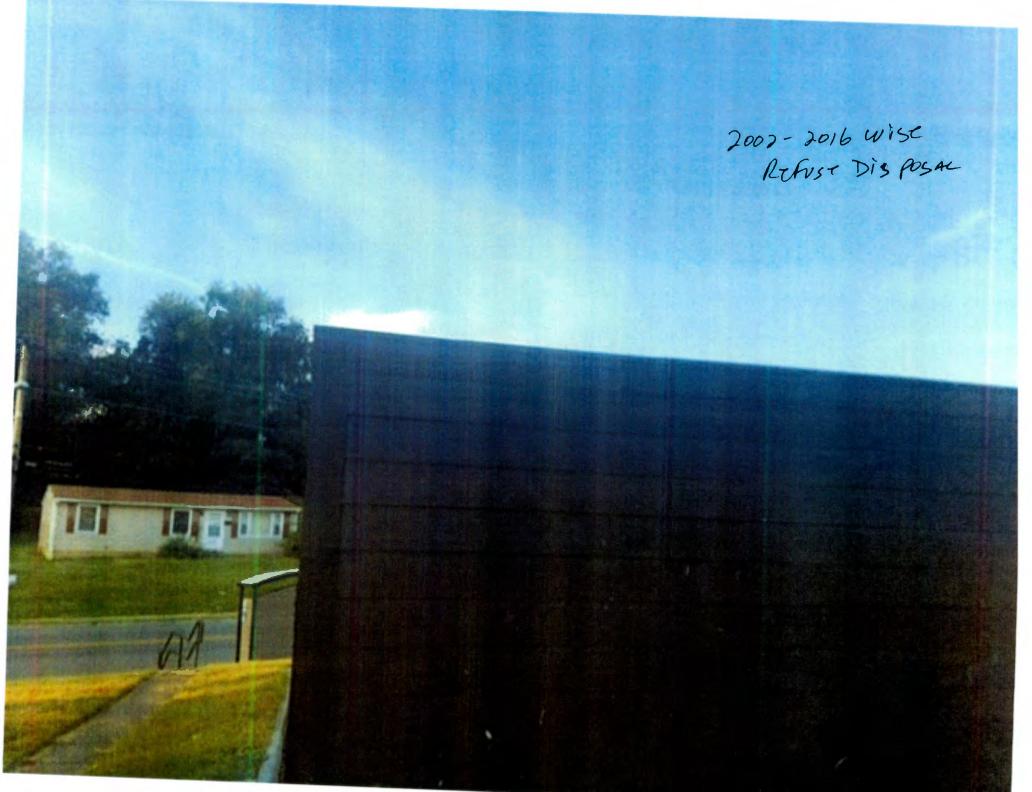
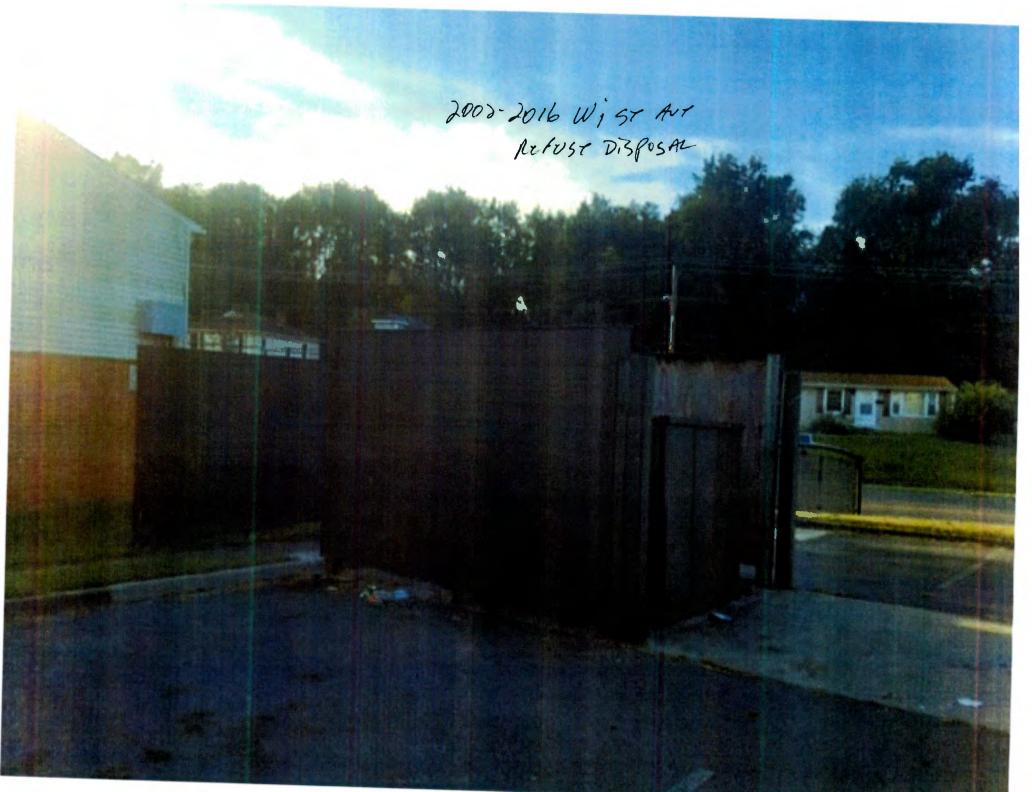
Project Location: 2034 Indian Village Ln

Refuse Disposal-Site - Broken/Damaged Enclosure-Inadequate Outside Storage Space (Refuse Disposal) - L2 Refuse area wall/gate is damaged or leaning (risk of collapsing)

After inspecting the dumpster enclosure, located across from Units 2002-2008 on the corner of Indian Village Lane, I found No damage to the framing. I found the structure to be sound, however I did find ply board sheeting detached from the framing caused by weather conditions.

City of Roanoke Redevelopment and Housing Authority requests that the 2.86 points that where deducted be reinstated as part of our overall score based on the documentation provided and the fact that there was no violation of UPCS protocol.
