## **Critical Areas Report**

Cedarbrook School Demolition Site  
Shoreline, Washington

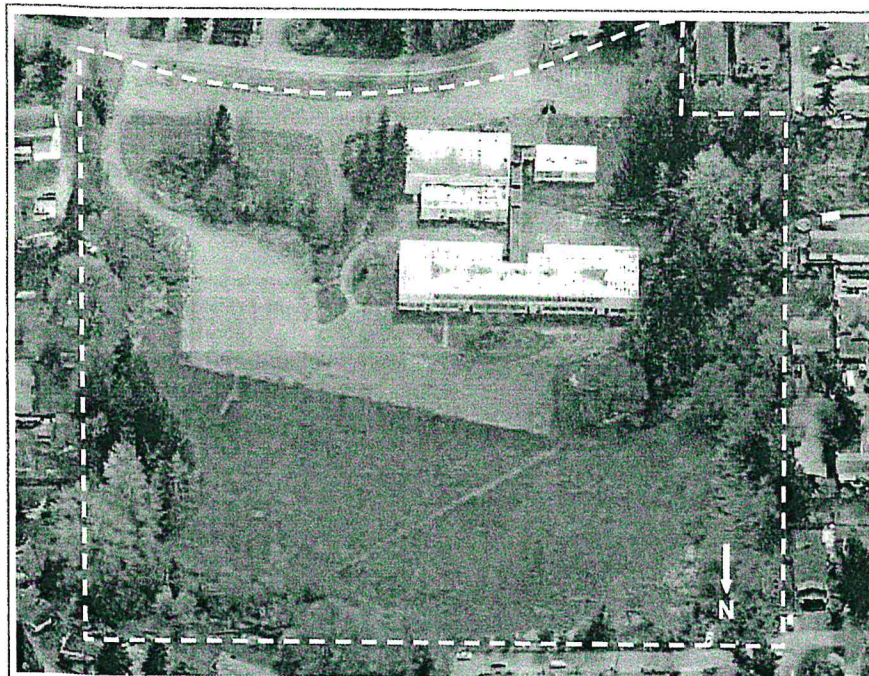
Birds-eye view of property looking south

Elevations on the property range from 275 feet in the southwest corner to 225 in the northeast corner with topography generally sloping from southwest to northeast. The site was graded when the school was constructed such that there is a relatively flat parking area along the south edge and a relatively flat play field to the north. Some short steep slopes and stairs are present in the middle portion of the site.

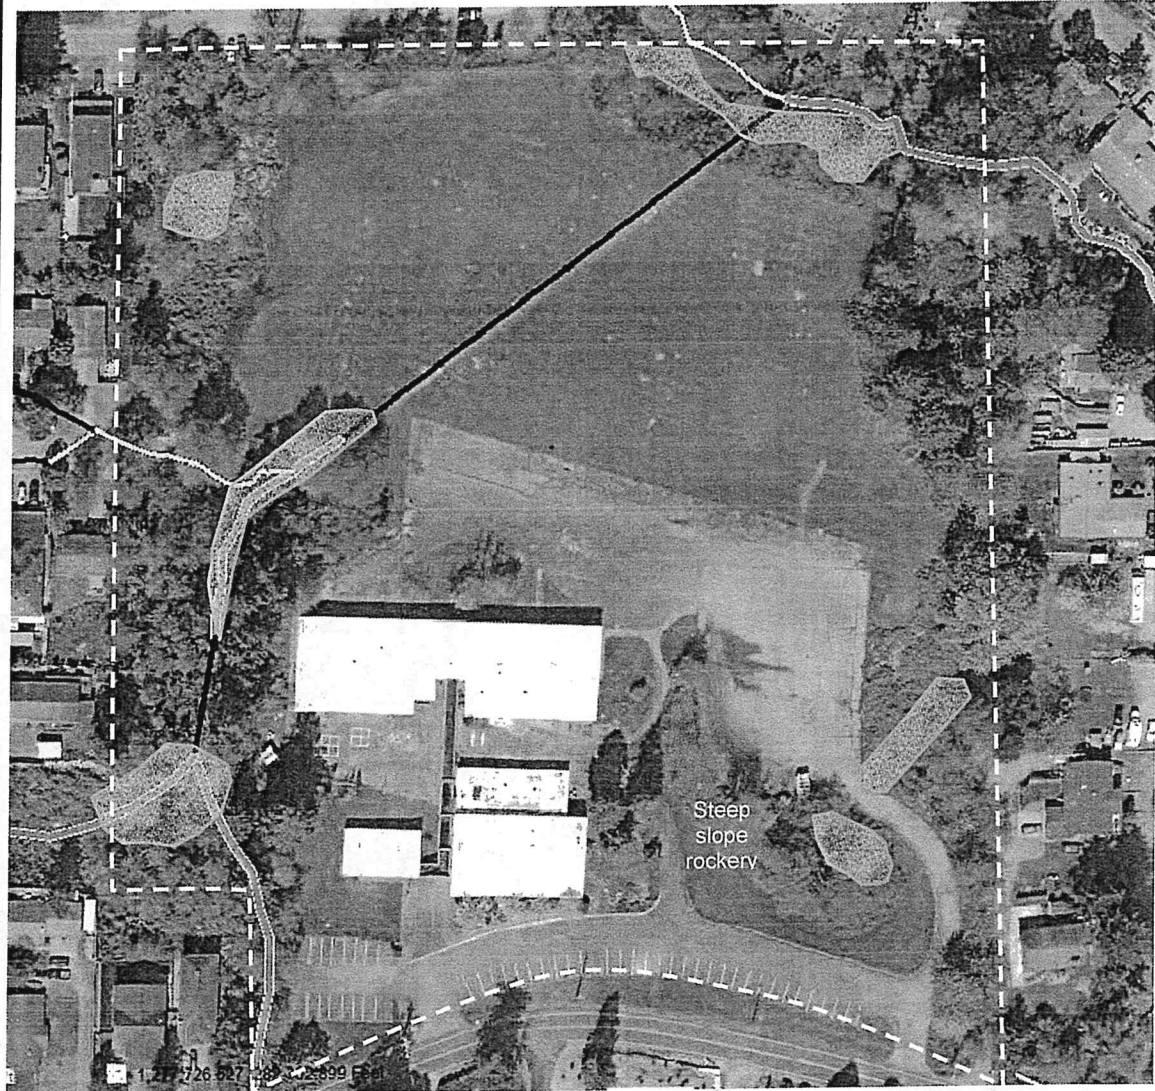
**FIGURE**  
**2**

**SHORELINE MAPPED CRITICAL AREAS**  
Cedarbrook School Site  
2000 NE Perkins Way Shoreline, Washington

The National Wetland Inventory (NWI) does not map any wetlands on the property. The City of Shoreline GIS maps show six wetlands distributed across the site (Figure 2). Several mapped tributaries are shown to join together and flow to Whisper Creek in the northeast corner of the site. These mapped features are similar to what was observed during the 2016 site visit.

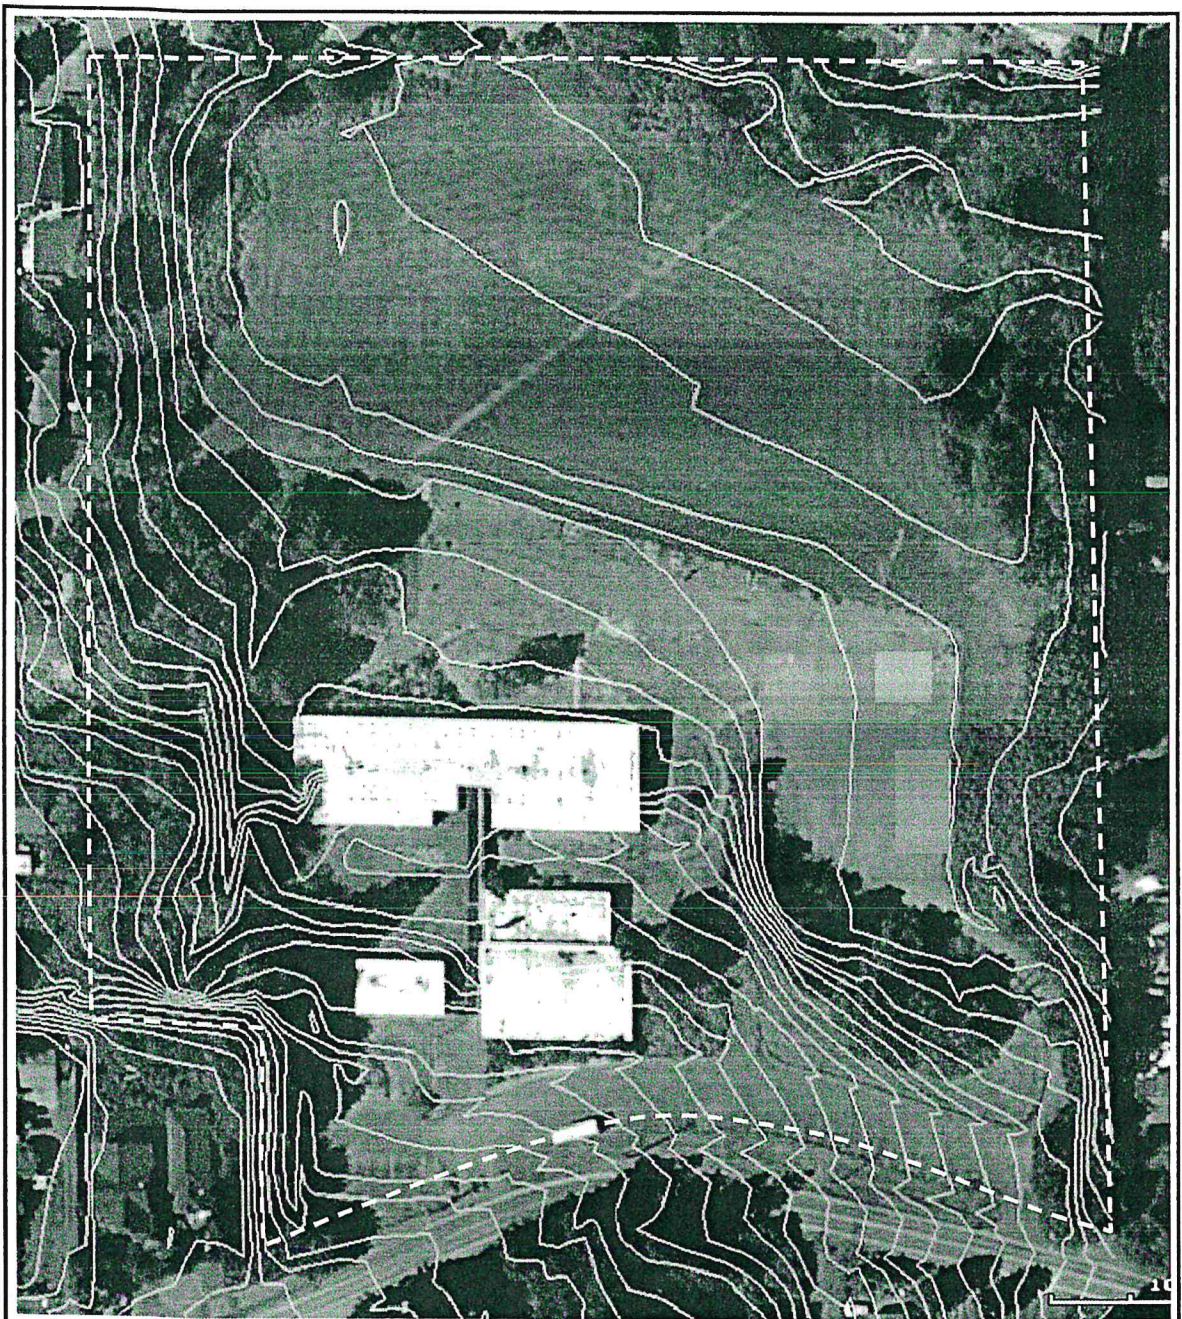
**FIGURE**  
**3**

Topography from City of Shoreline GIS database – 2' contours

**PARCEL AERIAL / TOPOGRAPHY**  
Cedarbrook School Site  
2000 NE Perkins Way Shoreline, Washington

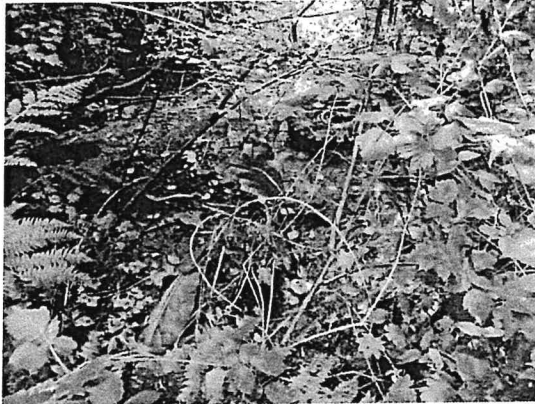
Photo 1. Wetland A looking north

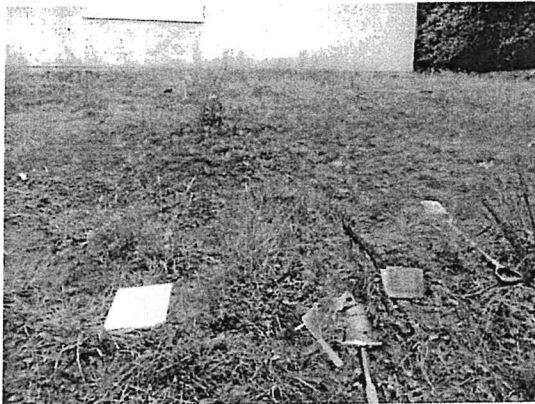
Photo 3. Wetland B looking north along east edge of wetland.

Wetland B is a small hillslope seep wetland located between two of the buildings. The north edge of the wetland abuts an asphalt playground. The eastern portion of Wetland B is mowed herbaceous vegetation with a mix of grasses and herbs (*Juncus effusus*, *Plantago spp.*, *Carex spp.*, *Ranunculus repens*, etc). The western portion of Wetland B is dominated by Himalayan blackberry and cottonwood saplings. Soils are low chroma with prominent redox concentrations starting at the surface. The water table was observed within 12 inches of the surface near the edge of the wetland. Water flows out of the wetland across the paved area.

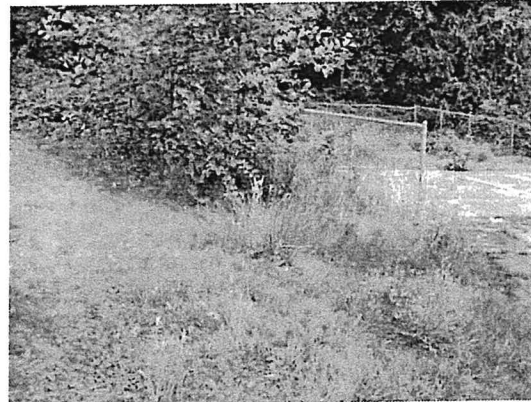
Photo 4. Wetland B looking west

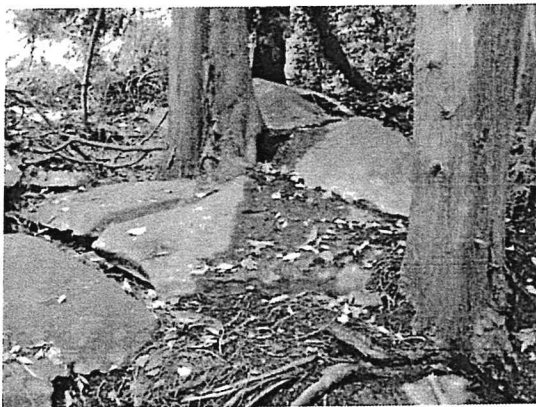
Photo 5. Wetland C seeps downslope to unnamed tributary and Wetland D.

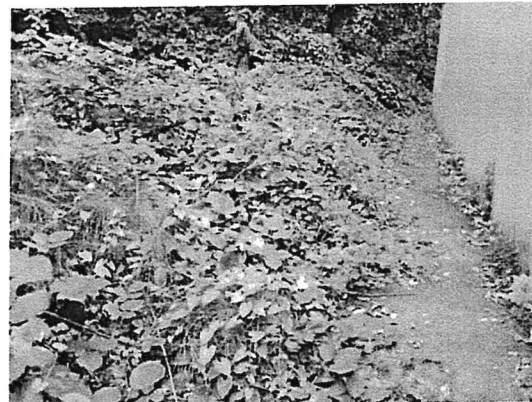
Photo 6. Wetland D looking north. Wetland extends to sidewalk along building

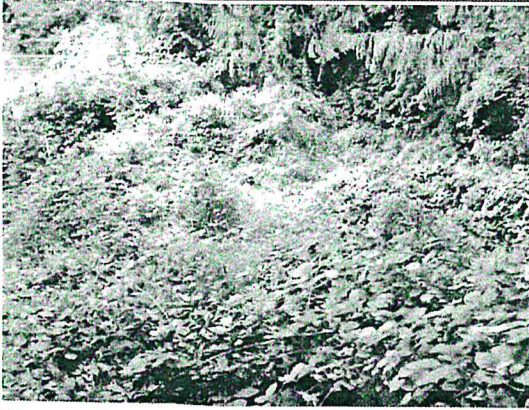
Photo 9. Wetland D looking south. Wetland extends to sidewalk along building. Creek is on photo right.

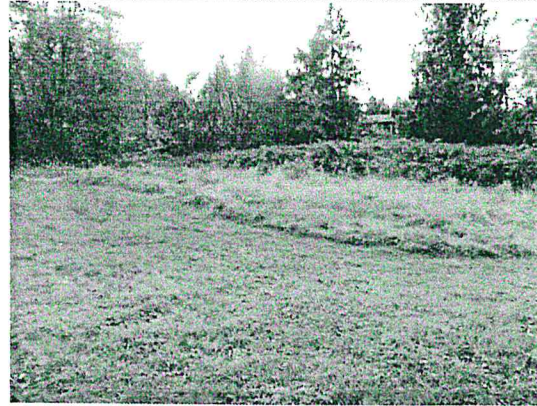
Photo 10. Wetland E looking southwest

Wetland E is a large wetland complex along the northern part of the west edge of the parcel. This wetland is fed by a series of hillslope seeps. Several inches of water was observed in the upslope portion of this wetland. Vegetation in Wetland E includes a

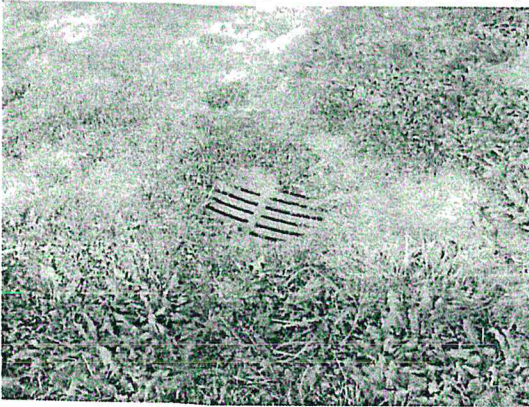
Photo 11. Surface drain in playfield at base of Wetland E

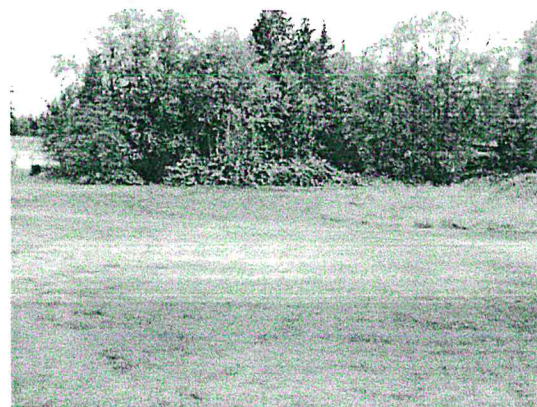
Photo 12. Wetland E looking south. Greener vegetation is approximate extent of wetland.

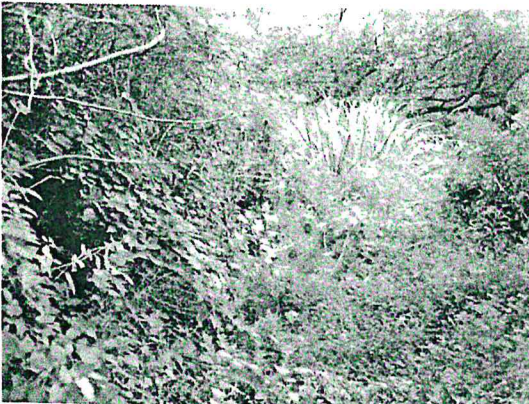
Photo 13. Wetland F fringing wetland on Whisper Creek

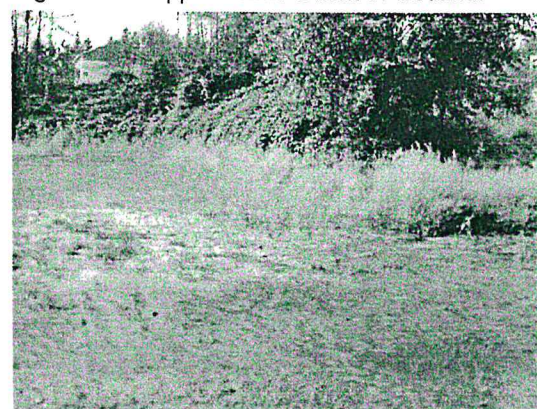
Photo 14. Wetland G starts as hillslope seeps along the cut slope and flows across asphalt parking area.

Wetland G is a slope wetland fed by a series of hillslope seeps. The hillslope at this location was cut back to create a flat asphalt parking lot for the school, which intercepted subsurface flows and formed a wetland. Water from the seeps sheet-flows across the asphalt parking surface to the east. Water was flowing up to several inches in depth on the parking lot in September 2016 despite a recent period of unusually dry conditions. Lack of maintenance on the parking lot has resulted in growth of herbaceous wetland vegetation across much of the inundated area, however soils have not developed on the surface of the asphalt beyond a film of moss and organic matter present in localized parts of the parking lot. Dominant vegetation on the hillslope portion of this wetland includes willow and red alder with an understory of salmonberry and other wetland shrubs, Himalayan blackberry, and reed canarygrass. East of the parking lot the wetland extends a short distance, but then the water goes subsurface so hydric soil and hydrology indicators are lost. Wetland G did not have a visible surface connection to downstream waters but likely has a shallow subsurface connection to Whisper Creek to the north and east.

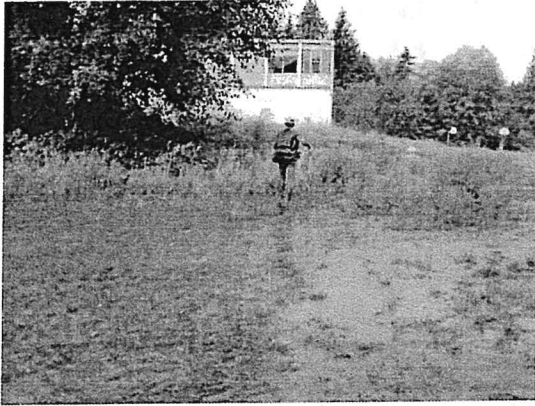
Photo 15. Looking west from middle of Wetland G across water flowing over asphalt parking area.

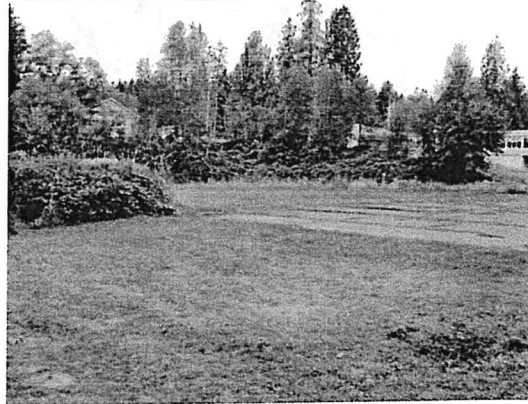
Photo 16. Looking southwest across wetland G from northeast corner of wetland.

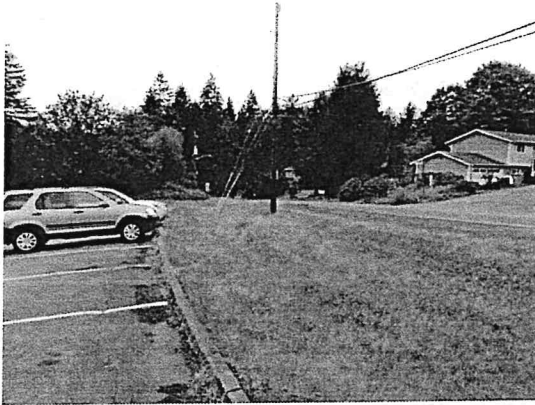
Photo 17. Wetland H. Looking southeast along wetland H roadside swale along Perkins Way.

Wetland H is a constructed roadside swale along NE Perkins way. Much of the swale is regularly mowed and maintained by the City. This wetland is actually in the right-of way to NE Perkins Way. Vegetation consists of lawn grasses (e.g. *Agrostis* spp. and *Holchus lanatus*) and herbaceous plants including *Equisetum arvense*, *Ranunculus repens* and several sedge and rush species. The swale ends in a catchbasin to a culvert under the driveway. Water flows through the culvert to join a small tributary stream that flows east towards Whisper Creek. Soils in the wetland are sandy loam with lower chroma matrix than adjacent upland soils and prominent redox features at 10YR 4/6 starting within 3 inches of the surface. Soils were moist throughout the profile within the wetland in comparison to dry soils throughout the profile in the adjacent upland.

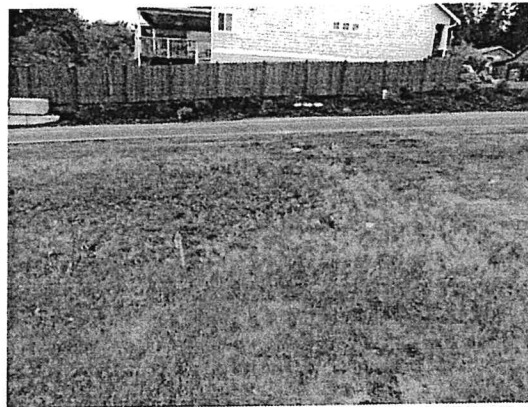
Photo 18. Wetland H. Plots and wetland boundary along west end of Wetland H.

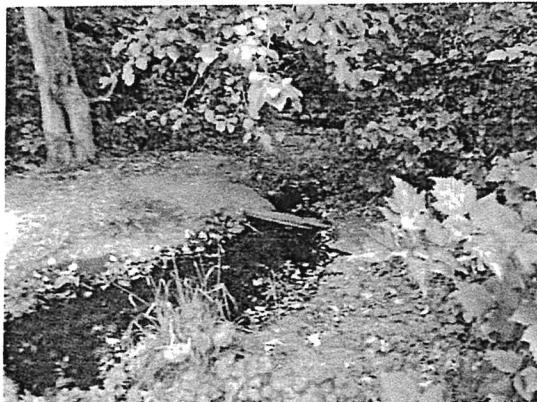
Photo 19. Upper (southern) reach of unnamed tributary as it enters wetland A.

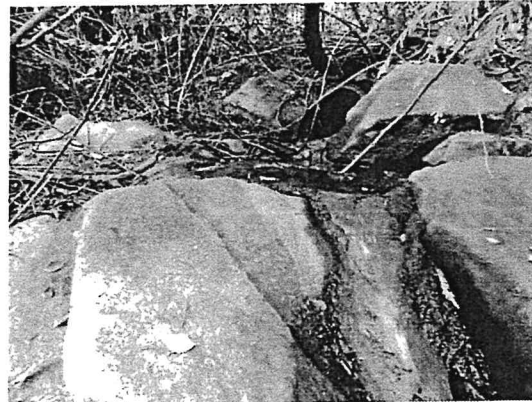
Photo 20. Unnamed tributary flowing out of pipe near upstream section of Wetland D.

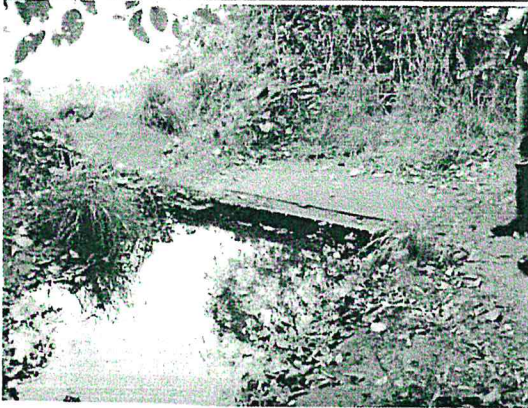
Photo 21. Unnamed tributary flowing to piped reach under playfields.

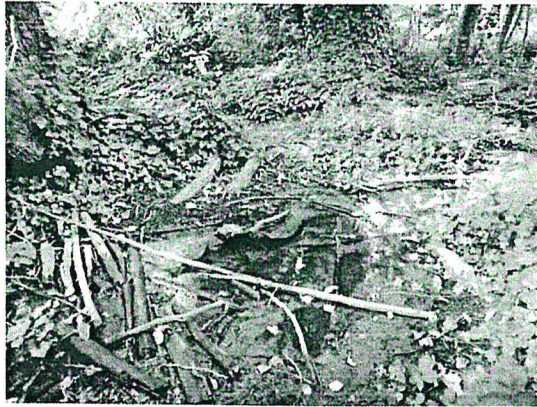
Photo 22. Outfall of east unnamed tributary pipe to Whisper Creek

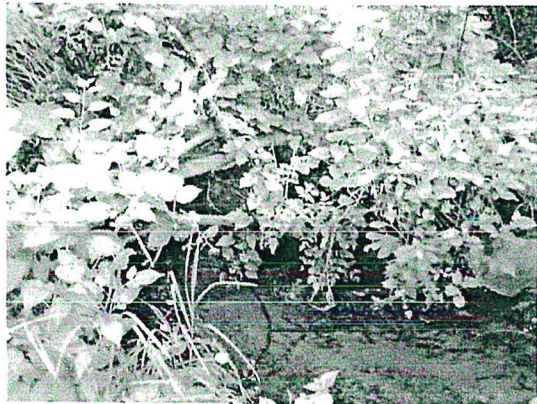
Photo 24. Whisper Creek has fringing wetland.

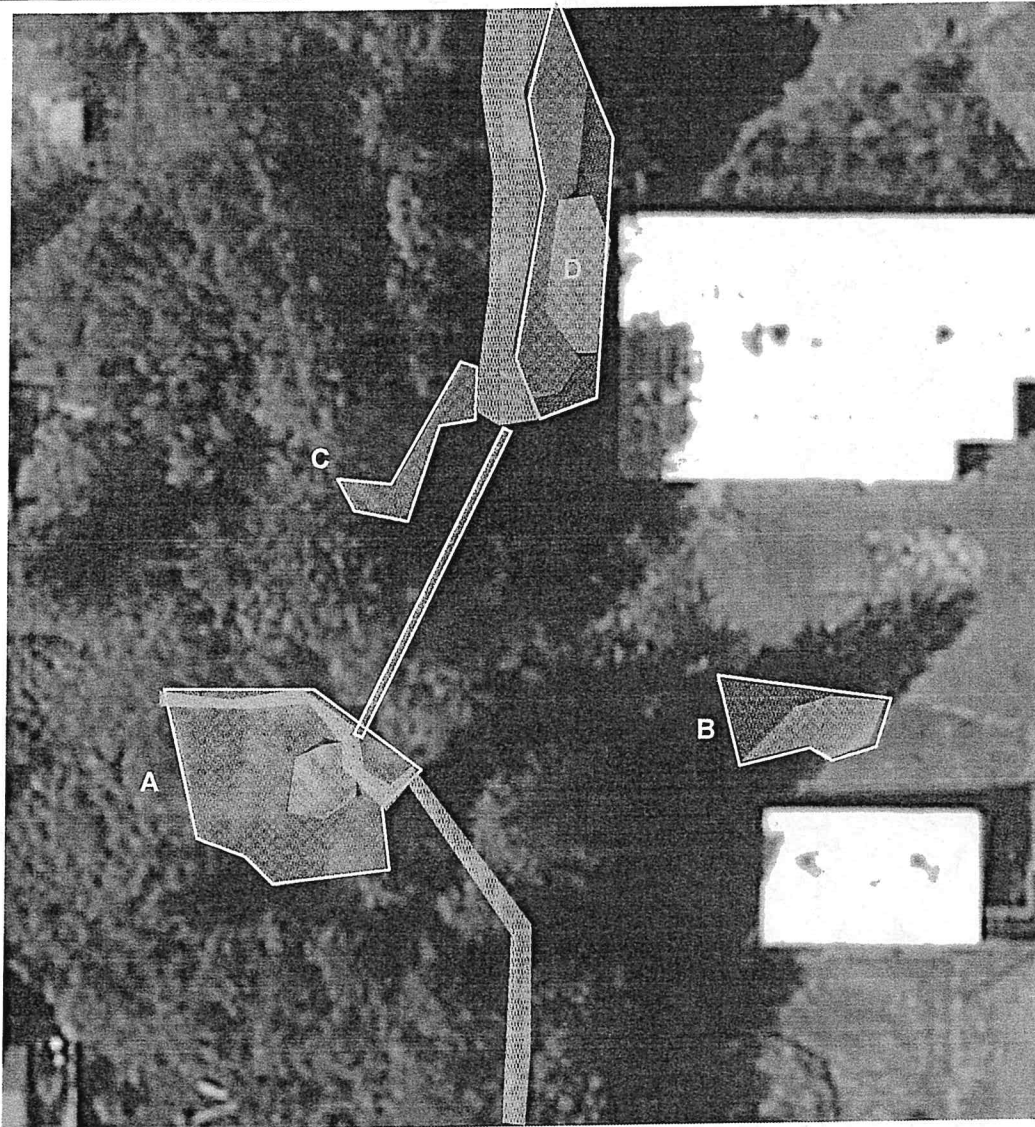
**RATING  
FIGURE  
1a**

**COWARDIN – WETLANDS A-D**  
Cedarbrook School Site  
2000 NE Perkins Way Shoreline, Washington

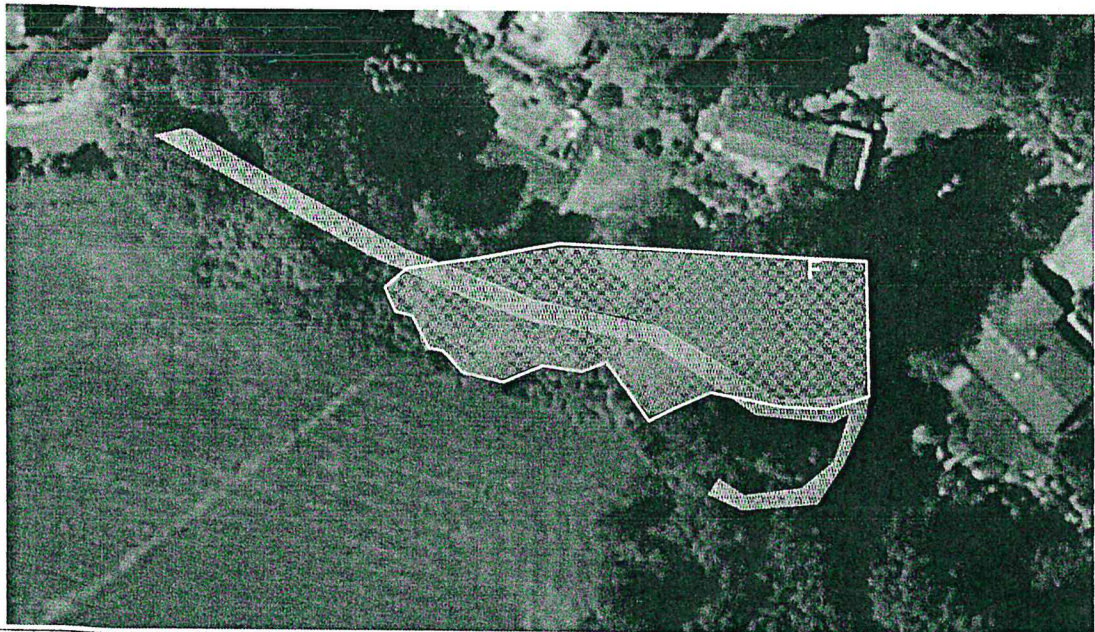
**RATING  
FIGURE  
1b**

**COWARDIN – WETLANDS E & F**  
Cedarbrook School Site  
2000 NE Perkins Way Shoreline, Washington

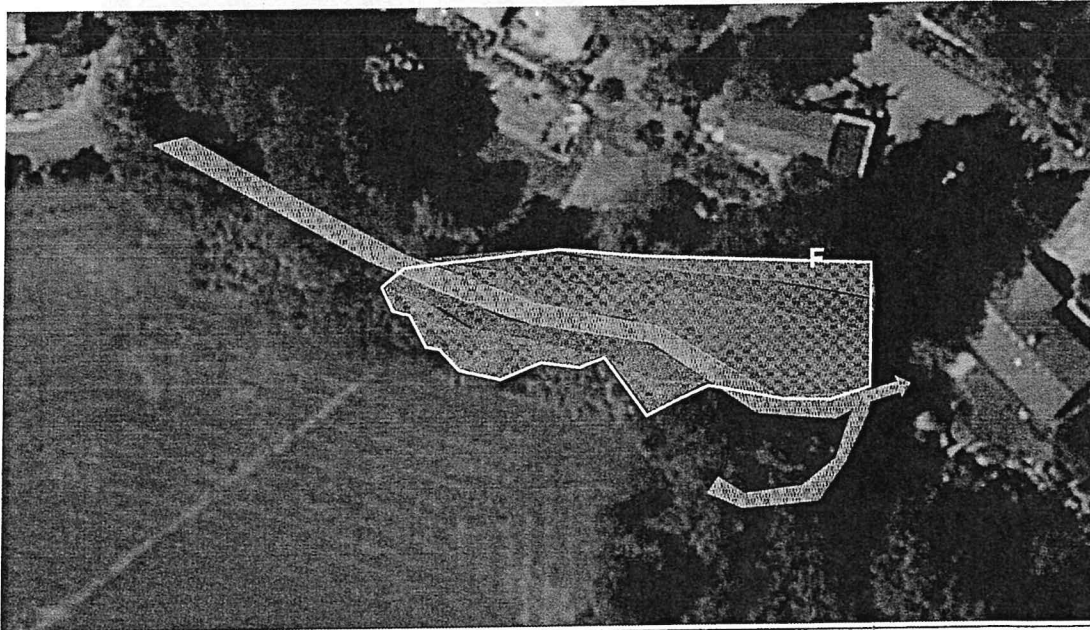
**RATING  
FIGURE  
2b**

**HYDROPERIODS – WETLANDS E & F**  
Cedarbrook School Site  
2000 NE Perkins Way Shoreline, Washington

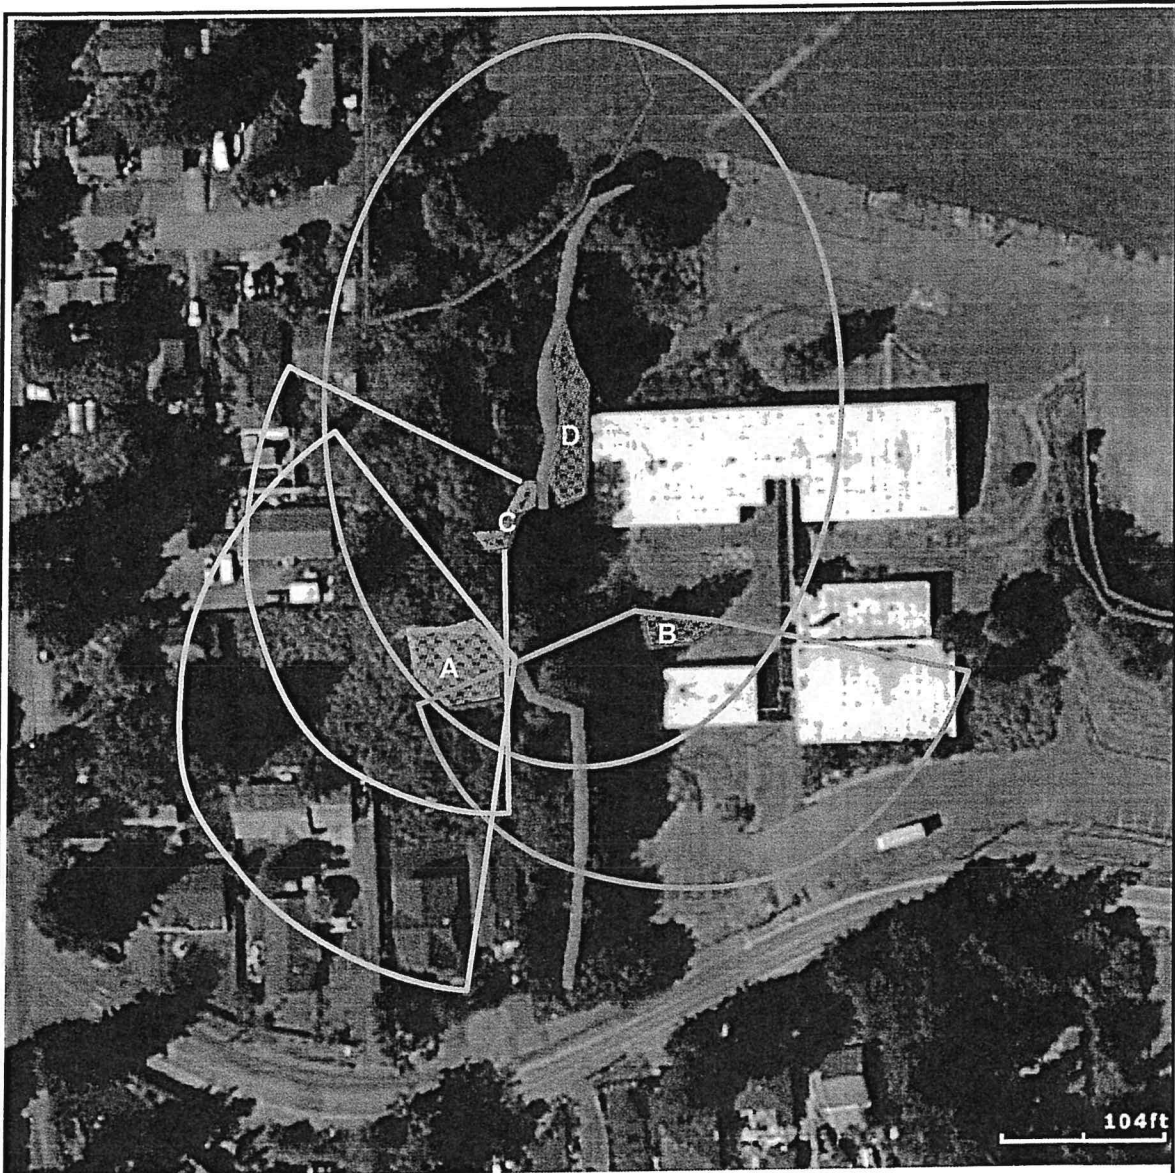
**RATING  
 FIGURE  
 3a**

**150' BUFFER – WETLANDS A-D**  
 Cedarbrook School Site  
 2000 NE Perkins Way Shoreline, Washington

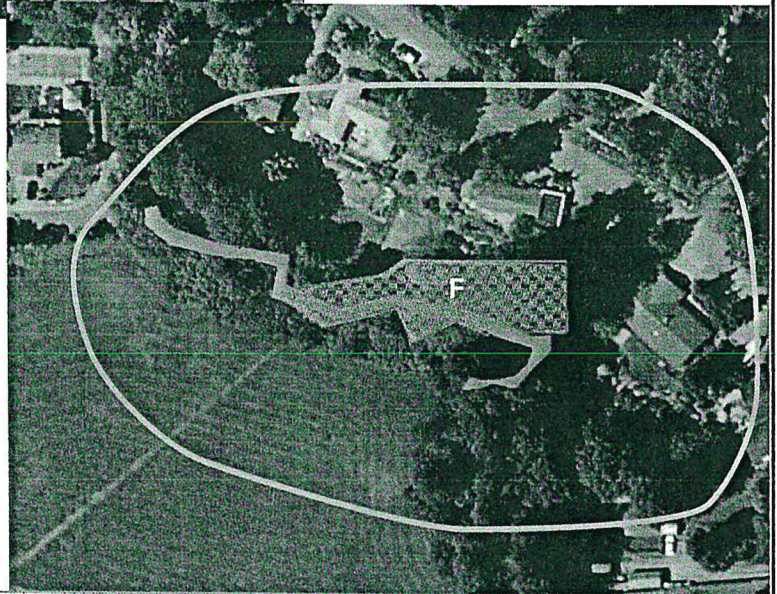
**RATING  
FIGURE  
3b**

**150' BUFFER – WETLANDS E & F**  
Cedarbrook School Site  
2000 NE Perkins Way Shoreline, Washington

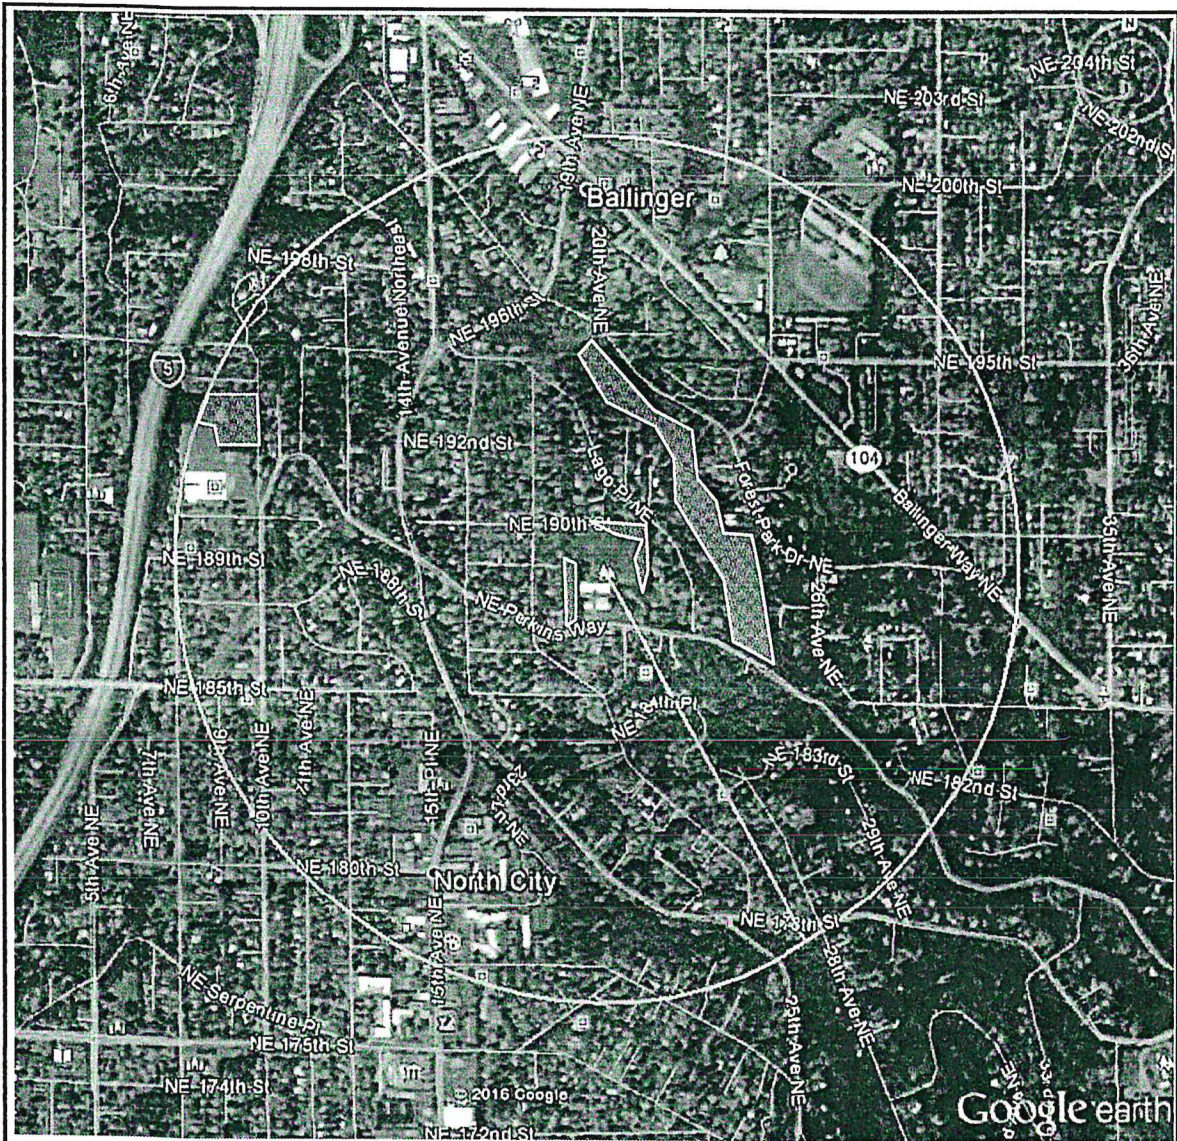
1km Radius – All wetlands

- No accessible habitat
- No relatively undisturbed habitat
- Low to moderate intensity land use < 10 percent
- Balance is high intensity

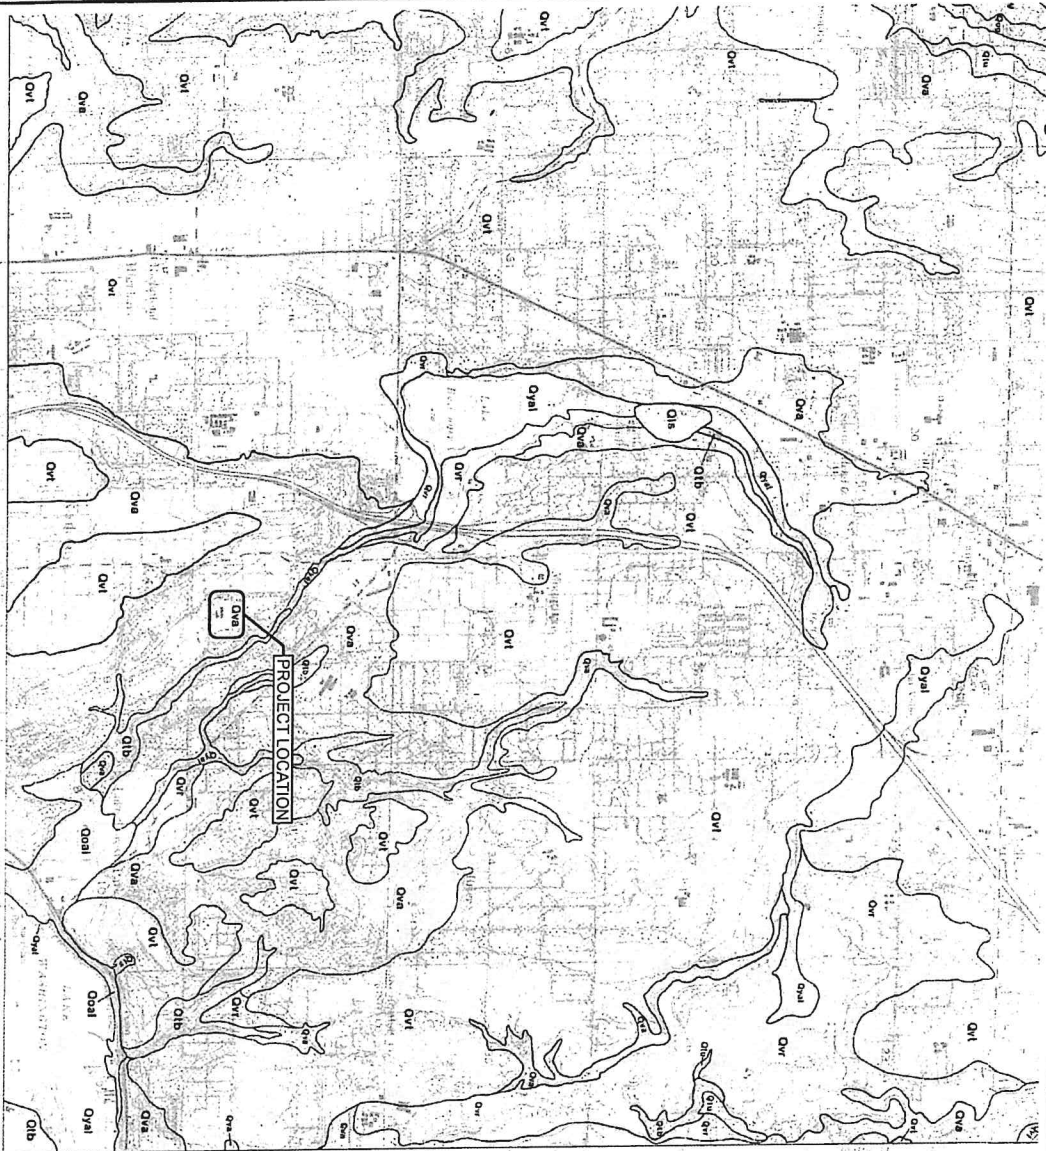
<p><b>GEOLOGY MAP</b>  <b>CEDARBROOK ELEMENTARY SCHOOL</b>                  SHORLINE, WASHINGTON</p>	<p><b>PBS Engineering and Environmental Inc.</b>                  2517 Eastlake Ave East, Ste 100                  Seattle, WA 98102                  206.233.9639                  pbsusa.com</p>
<p><b>PROJECT</b> 40958.011  <b>DATE</b> MAY 2017  <b>FIGURE</b> 4</p>

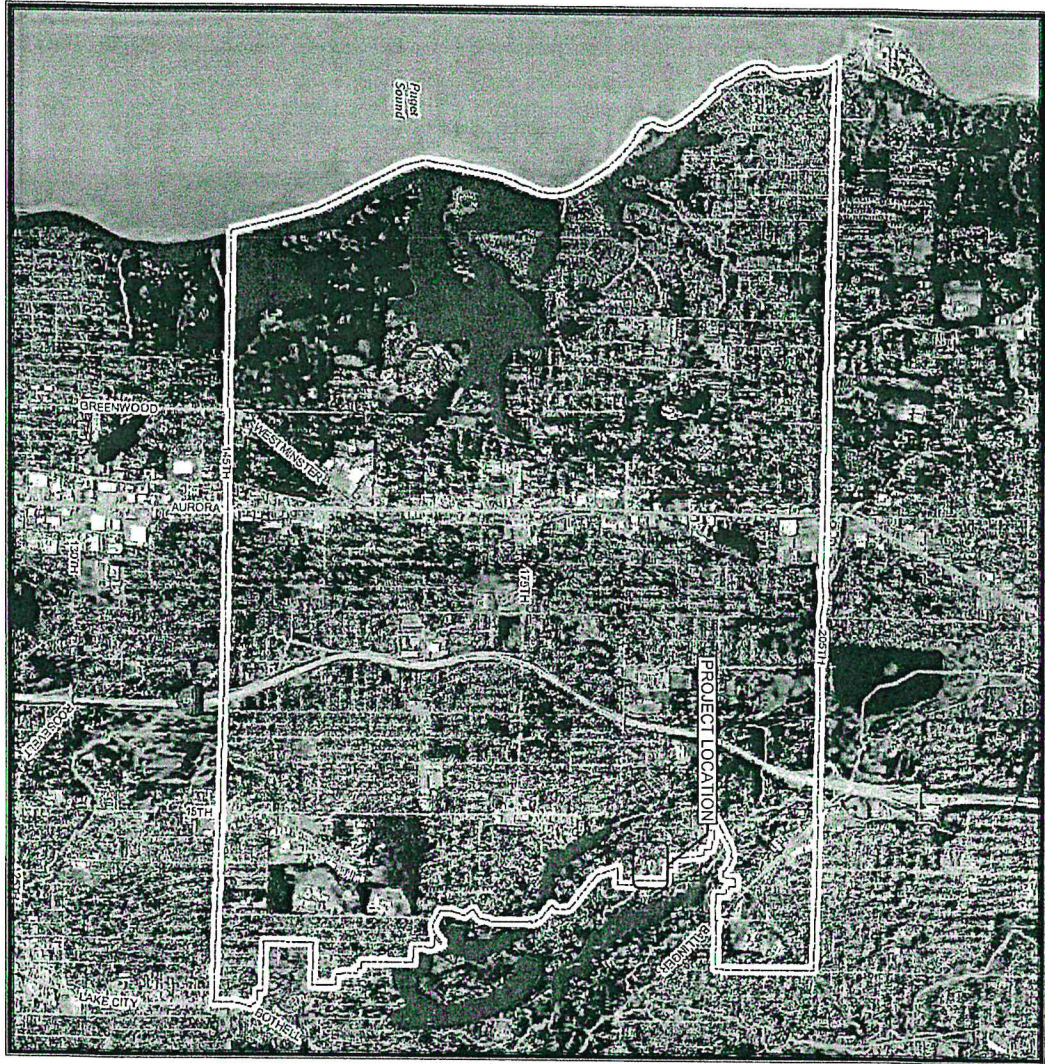
# CITY OF SHORELINE Landslide Hazard Areas
