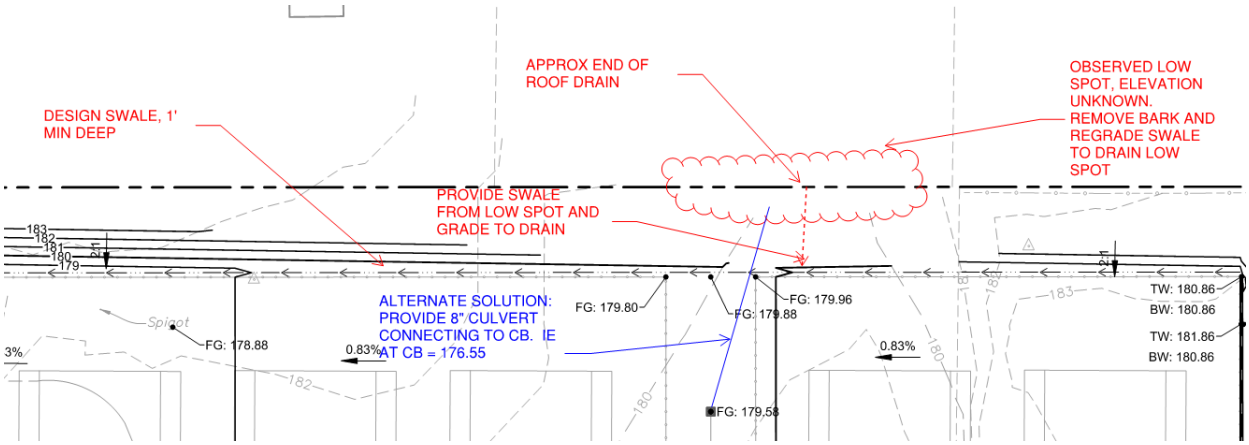
Mike and I field reviewed the Soule property to the north of the tennis courts. We observed a 4' drain pipe from the property outletting onto the school district property. It is most likely the roof drainage. This pipe was not identified in the design survey. The survey contours and spot elevations do not pick up the elevation at the low spot in the Soule property back yard near their fence. It is lower than 180.

The design intent shown on the drawings is to provide a swale along the north edge of the tennis courts. The V-ditch should be a minimum of 1 foot deep and slope to the west, eventually outletting into the ditch along Frontier. I see two possible solutions:

Option 1. Establish the ditch as shown below in red. Removing bark and regrading is necessary to provide the ditch 1 foot deep and maintain a slope of .83% to the west. The elevation of the low spot should be obtained as well as the outlet end of the roof drain pipe to confirm this depth of swale is adequate.

Option 2. Provide a 8" culvert from the low spot at the north property line and connect to the tennis court CB. Repair HMA paving.
