From: Doreen Gavin <DGAVIN@AHBL.com>
Sent: Monday, January 7, 2019 11:08 AM
To: Eatch Beck - Capital Projects <BeckE@ckschools.org>; Thiel Sydney - Capital Projects <SydneyT@ckschools.org>; Nick Rheaume <NRheaume@AHBL.com>
Cc: Johnny Hong <jhong@integrusarch.com>; Richard Wilson (rwilson@integrusarch.com) <rwilson@integrusarch.com>; Mike Hager <mhager@AHBL.com>; Craig Skipton <CSkipton@AHBL.com>
Subject: RE: Soule Drainage Pipe

Mike and I field reviewed the Soule property to the north of the tennis courts. We observed a 4' drain pipe from the property outletting onto the school district property. It is most likely the roof drainage. This pipe was not identified in the design survey. The survey contours and spot elevations do not pick up the elevation at the low spot in the Soule property back yard near their fence. It is lower than 180.

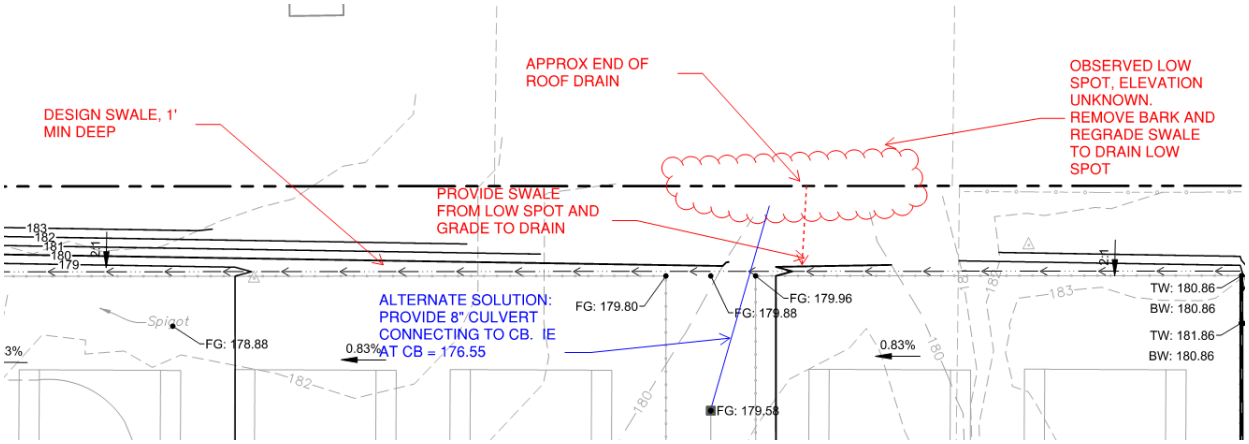
The design intent shown on the drawings is to provide a swale along the north edge of the tennis courts. The V-ditch should be a minimum of 1 foot deep and slope to the west, eventually outletting into the ditch along Frontier. I see two possible solutions:

Option 1. Establish the ditch as shown below in red. Removing bark and regrading is necessary to provide the ditch 1 foot deep and maintain a slope of .83% to the west. The elevation of the low spot should be obtained as well as the outlet end of the roof drain pipe to confirm this depth of swale is adequate.

Option 2. Provide a 8" culvert from the low spot at the north property line and connect to the tennis court CB. Repair HMA paving.
