From: Thiel Sydney - Capital Projects on behalf of Thiel Sydney - Capital Projects <SydneyT@ckschools.org>
To: licensing@ahbl.com; Eatch Beck - Capital Projects; Nick Rheaume
Cc: Johnny Hong; Richard Wilson (rwilson@integrusarch.com); Mike Hager; Craig Skipton
Subject: RE: Soule Drainage Pipe
Date: Thursday, January 3, 2019 3:42:34 PM
Attachments: image001.png

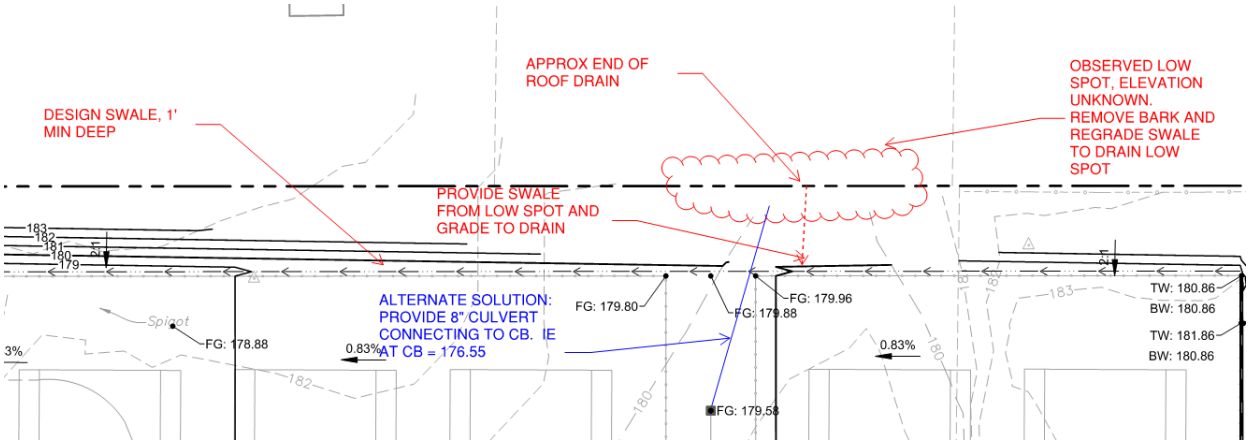
Mike and I field reviewed the Soule property to the north of the tennis courts. We observed a 4' drain pipe from the property outletting onto the school district property. It is most likely the roof drainage. This pipe was not identified in the design survey. The survey contours and spot elevations do not pick up the elevation at the low spot in the Soule property back yard near their fence. It is lower than 180.

The design intent shown on the drawings is to provide a swale along the north edge of the tennis courts. The V-ditch should be a minimum of 1 foot deep and slope to the west, eventually outletting into the ditch along Frontier. I see two possible solutions:

Option 1. Establish the ditch as shown below in red. Removing bark and regrading is necessary to provide the ditch 1 foot deep and maintain a slope of .83% to the west. The elevation of the low spot should be obtained as well as the outlet end of the roof drain pipe to confirm this depth of swale is adequate.

Option 2. Provide a 8" culvert from the low spot at the north property line and connect to the tennis court CB. Repair HMA paving.
