I am writing to request technical review, in accordance with 24 CFR 902.68, regarding inspection report number 581624, filed on October 5, 2016 and released on October 13, 2016, for Lansdowne Park, AMP 201. The inspection report included a deduction of 7.50 points for Site/Grounds erosion/rutting areas (NLT) and a 2.94 point deduction for Site, overgrown vegetation. Total points deducted 10.44. We believe this is a material error which, if corrected, will result in a significant improvement in the property's overall score. Supporting documentation is enclosed for your review.

Office of Public Housing Real Estate Assessment Center Request for Technical Review (TR) or Database Adjustment (DBA) of a Physical Inspection Score

Inspection Number	<u>581624</u>	Project ID Number	<u>VA011000201</u>
Inspection Date	<u>10/05/2016</u>	Address of Property	<u>2624 SALEM TURNPIKE NW</u>
Project/Property Name	<u>Lansdowne Park</u>	City, State, Zip	<u>ROANOKE VA 24017</u>
Date of Request	<u>10/13/2016</u>	Contact Name	<u>David Bustamantye</u>
TR or DBA?	<u>TR</u>

TECHNICAL REVIEW REQUEST -INSPECTION
NUMBER 581624 – LANSDOWNE PARK

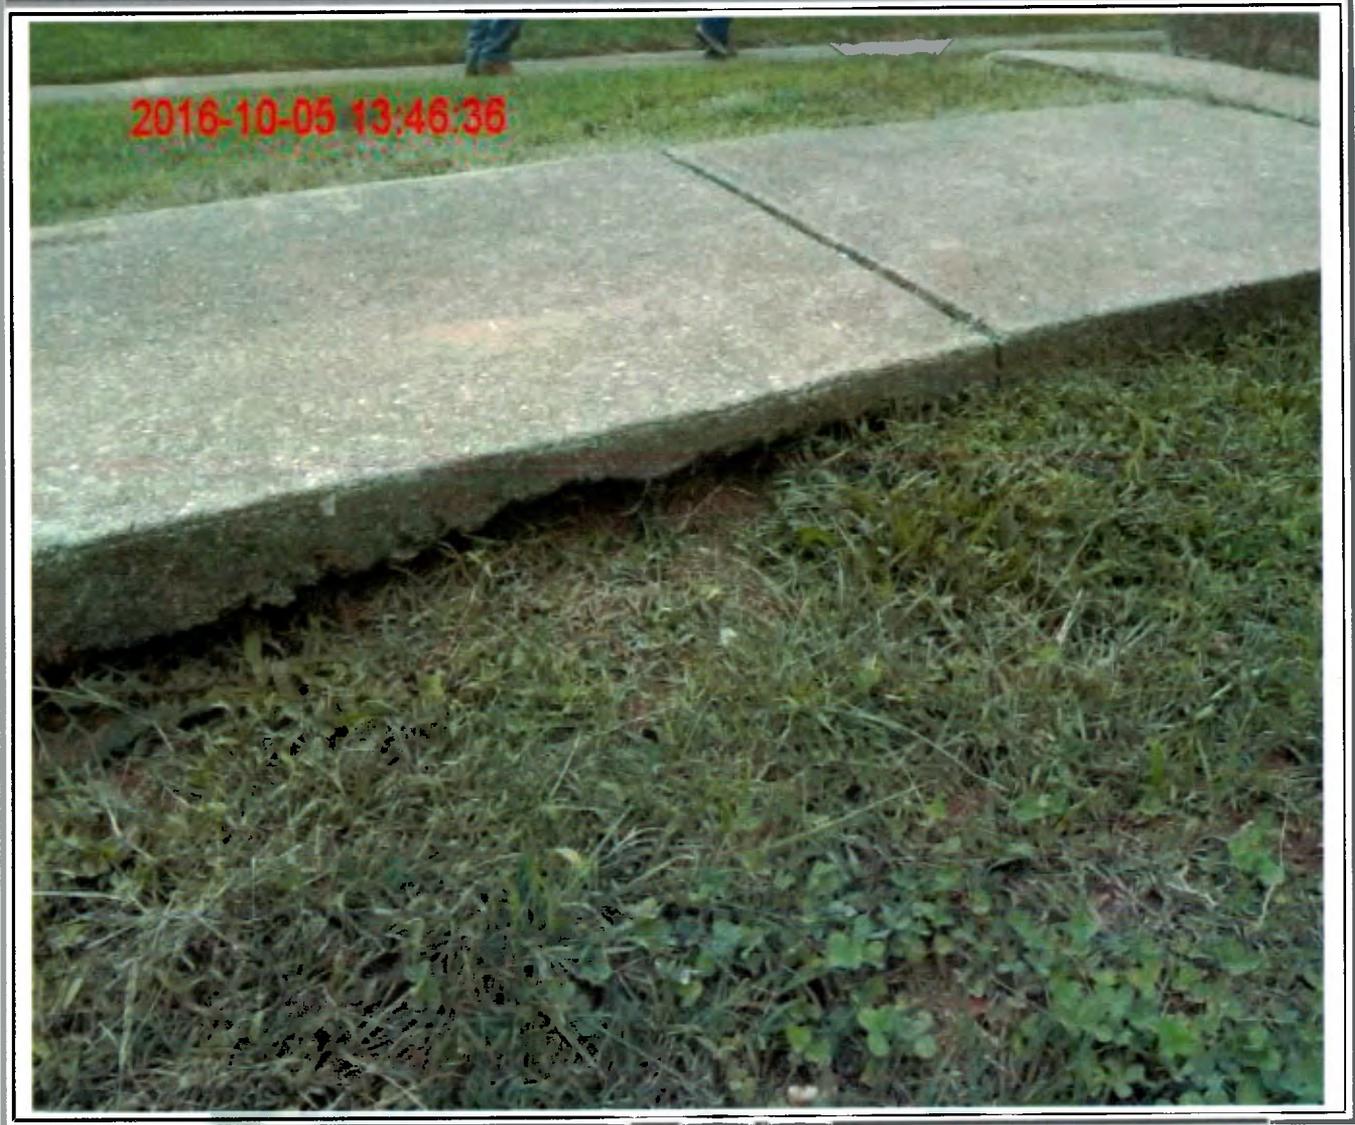
Print Photo

Site - OVERGROWN/PENETRATING VEGETATION (GROUNDS) L2, 2.94 POINT DEDUCTION.

Per the UPCS GUIDANCE & PROTOCOL CLARIFICATIONS bulletin issued by REAC on 5/13/2016 the picture described as overgrown vegetation does not meet the threshold for for citing this as a deficiency. As a matter of fact is it defined as what should not be considered overgrown vegetation by REAC Inspectors. RRHA requests that the 2.94 points be reinstated and that we receive a rescore.
