TECHNICAL REVIEW REQUEST
INSPECTION NUMBER 618261
LINCOLN TERRACE, AMP 202

HS – TRIPPING (HAZARDS)
5.91 POINT DEDUCTION

Office of Public Housing Real Estate Assessment Center Request for Technical Review (TR) or Database Adjustment (DBA) of a Physical Inspection Score

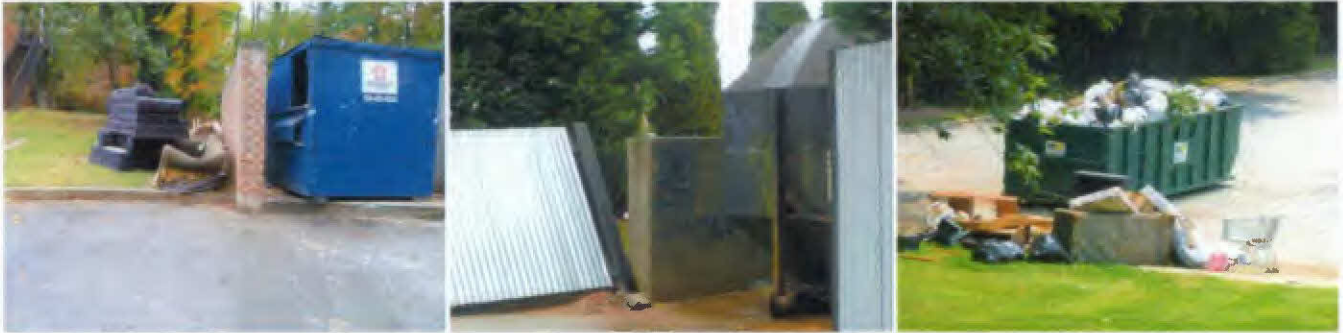
Trash Enclosures

The most common deficiency in this section is that the designated area is not large enough to store the garbage until collection. The other is that the enclosure has collapsed or leaning and in danger of falling.

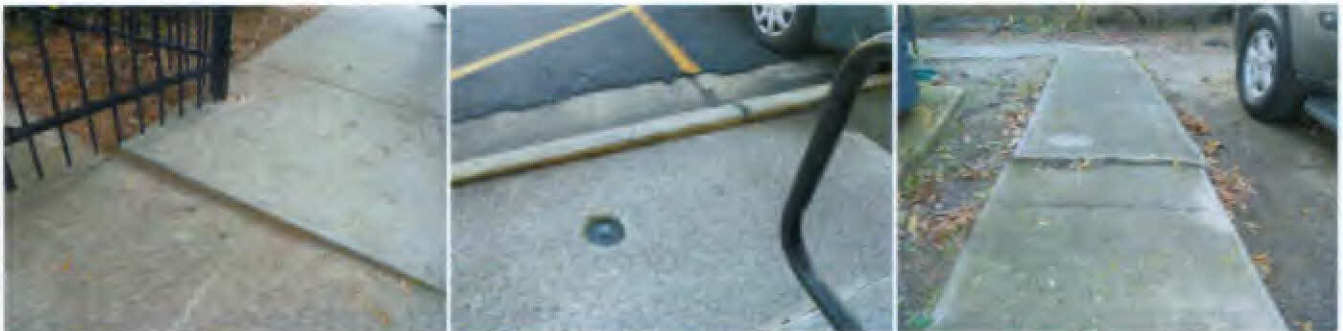
Trip Hazard

Trip hazards are common on sidewalks. Any place with an unintended abrupt change in elevation of $\frac{3}{4}$ " or more is a trip hazard. One area often overlooked is the junction where the sidewalk meets the curb. Sidewalks often sink over time and this causes the most common trip hazard.
